Hurley, F. (2005) 'A Preliminary Account of an Archaeological Excavation at Tankardstown (Knockmahon) Copper Mine, Bunmahon, Co. Waterford' *Journal of the Mining Heritage Trust of Ireland*, 5, pp.23-28

A PRELIMINARY ACCOUNT OF AN ARCHAEOLOGICAL EXCAVATION AT TANKARDSTOWN (KNOCKMAHON) COPPER MINE, BUNMAHON, CO. WATERFORD

by Flor Hurley

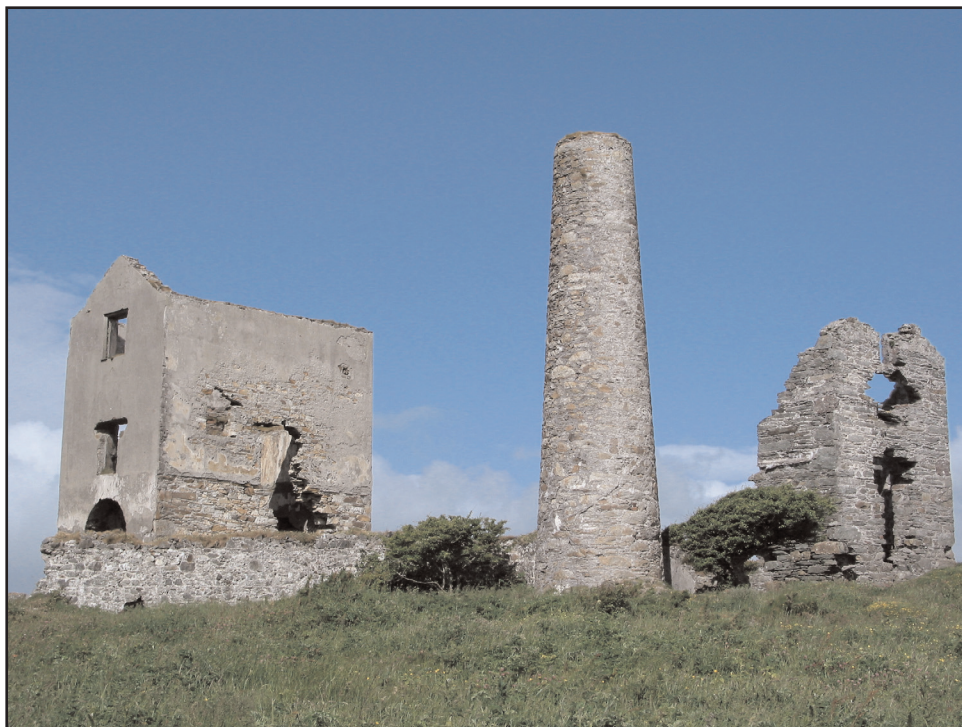
The motorist passing on the R675 road linking Dungarvan and Tramore cannot fail to notice the remains of the mining complex at Tankardstown dramatically located near the cliff edge. The site contains the substantial remains of two engine houses and a chimney stack. The best-preserved building is the pumping engine house, built in 1851 to hold a 50 inch diameter Cornish engine, which had been originally installed in a nearby mine at Kilduane, in 1837. The engine was dismantled in 1877 when the mine was abandoned. An attempt was made in 1906-07 to re-open the mine, but the works carried out were on a very small scale, and some appear to have been designed to give the appearance of a more substantial operation. The pumping engine house was later provided with a coat of cement rendering and a concrete platform built by its southwestern corner (fig. 1).

Figure 1. General view of Tankardstown Cornish engine house, stack and winding house before excavation

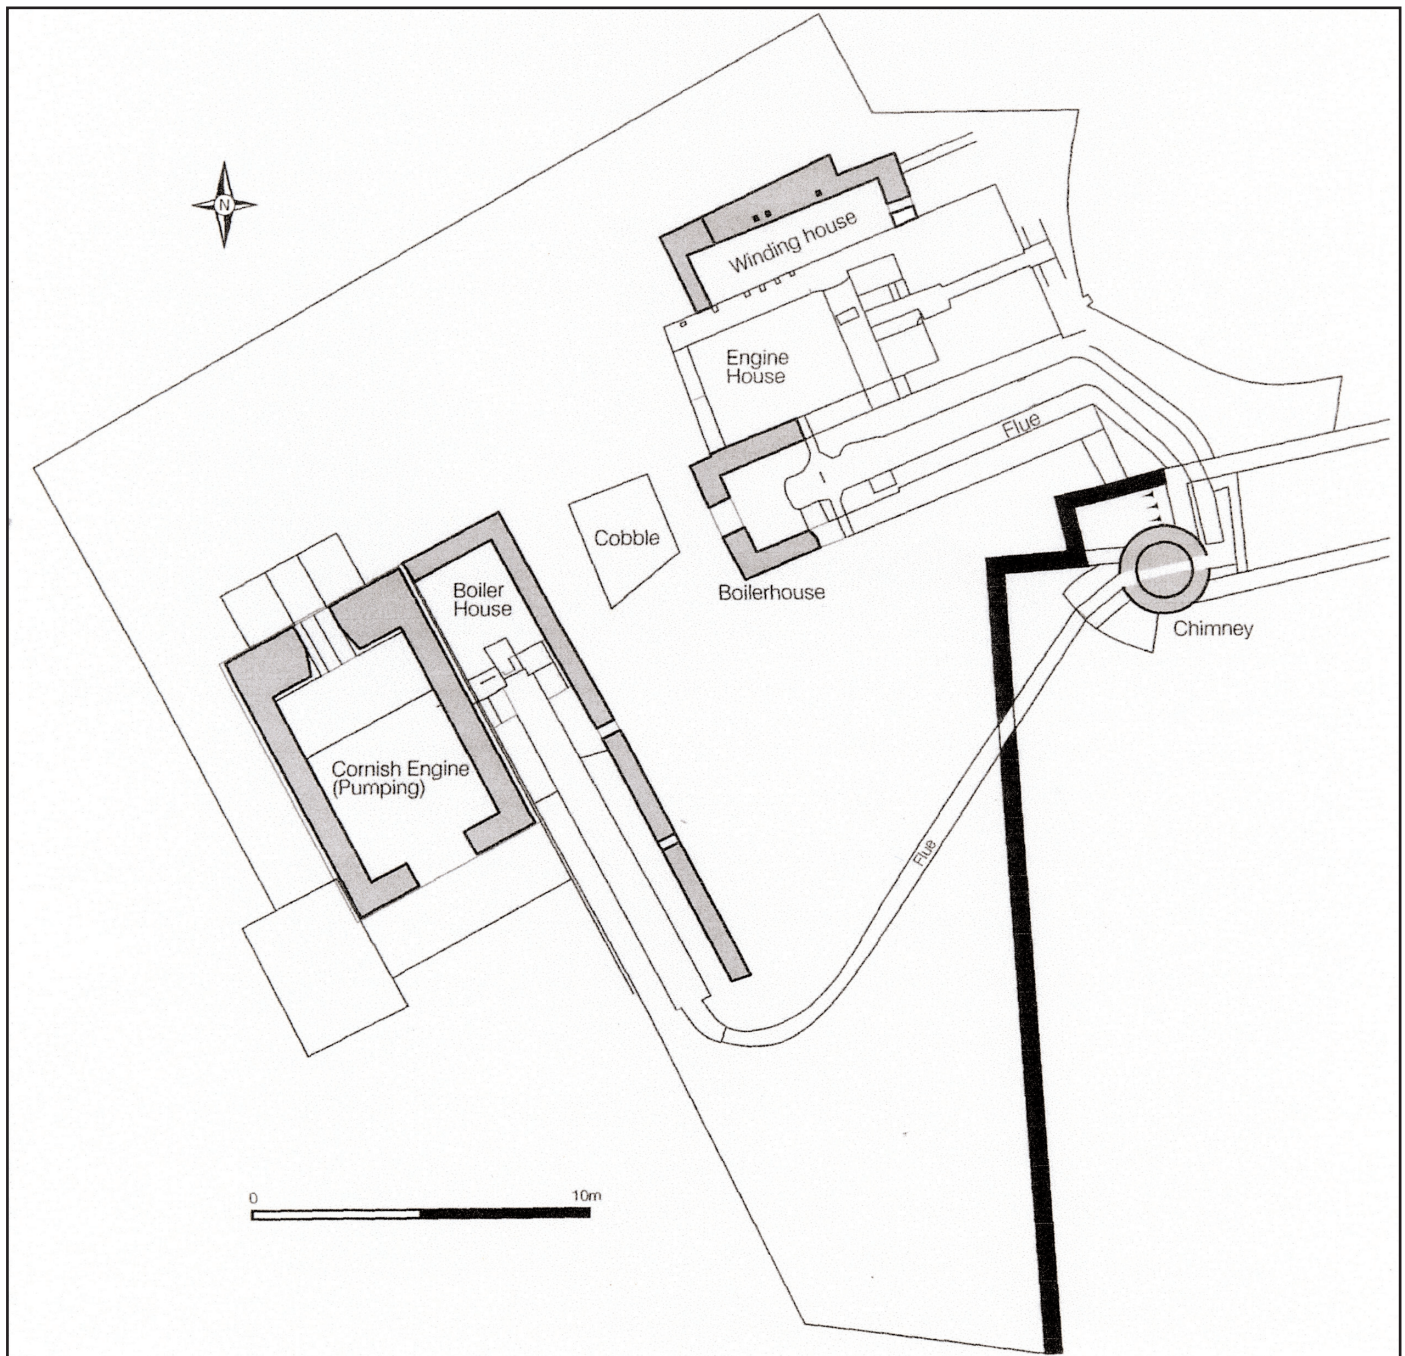
THE PUMPING ENGINE HOUSE (FIG. 2)

Figure 2. Interpretative plan of 2004 excavations

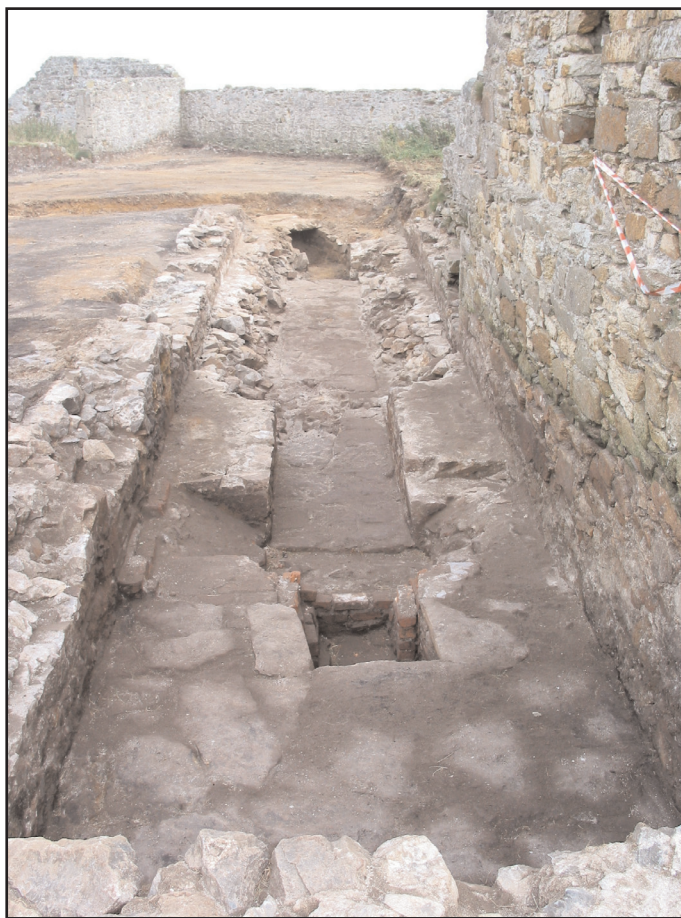
Figure 3. General view of boiler house for Cornish engine as excavated, looking north

PUMPING ENGINE BOILER HOUSE (FIG. 3)

ern end. A small trench was placed across the southern end of the feature to determine its form and condition. This revealed a masonry platform against both side walls with a central passageway. The edges of the platforms were in a poor condition, with much of the masonry being loose. A deposit of sandy silt containing much mortar and loose stone filled the trench. All of this material was removed by machine under close archaeological supervision, working from the more intact northern end of the building southwards. The central passageway, which had a flagged floor, was cleared by hand. A thin layer of coal dust overlay a paved area at the northern end, the area where the boiler was loaded with coal. Adjacent to this was a rectangular pit with a small shaft or opening in the base of its northern end. On the south side of the pit were two short ramps leading from the firing level into the central passageway. The two masonry platforms, on which the boiler would have been supported, were in a good condition at their northern end but their central and southern sides had collapsed. Traces of two brick vents in the eastern wall were also exposed at ground level.

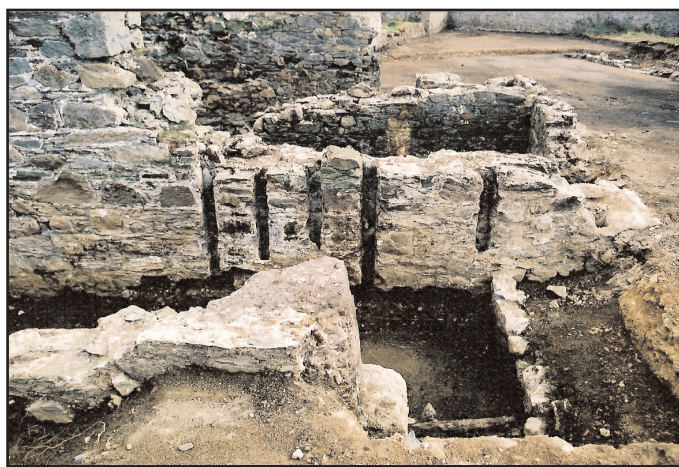
Figure 4. Detail of slots in winding drum structure. These are in wall dividing drum from winding engine house at rear of picture.

WINDING DRUM BUILDING (FIG. 4)

The most noticeable feature of the structure was the vertical slots built into the side walls. These were for timbers supporting the winding drum. There were six of these in the southern wall and three in the northern wall measuring, on average 0.12m by 0.15m. The distance between the easternmost three on the southern wall was virtually identical (c.0.49-0.51m) with the distance between the next two being just over twice that. Two of the slots on the northern wall correspond with two on the southern wall. Large horizontal slots are found at the base of the two side walls, the northern one containing the remains of the timber beam. A small rectangular opening in the base of the eastern wall could be for drainage.
