A PRELIMINARY REPORT ON CROOKHAVEN MINE, COUNTY CORK

By Paddy O'Sullivan

Abstract: A preliminary report is provided of the mining heritage of Crookhaven Mine, at Crookhaven, County Cork. The present remains are described and illustrated with reference to historical plans and sections. *Journal of the Mining Heritage Trust of Ireland*, 4, 2004, 11-18.

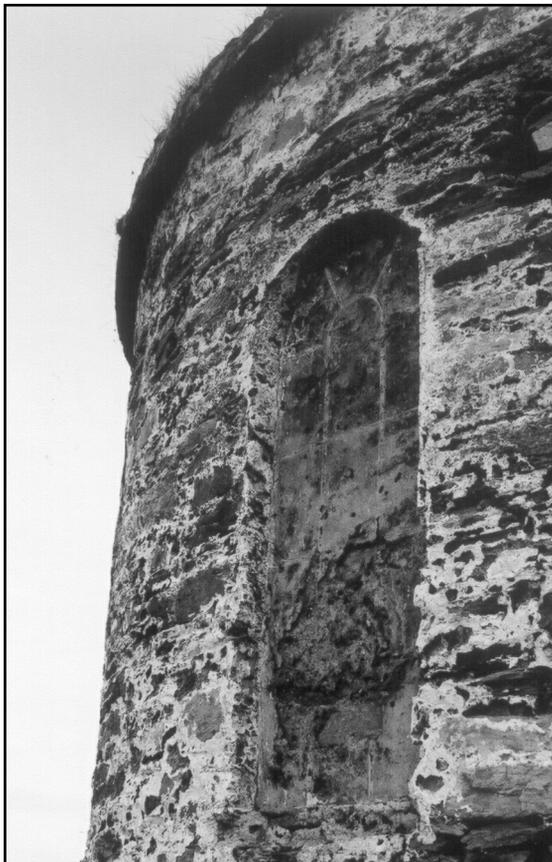
Figure 1. One of the painted "windows" in the southern powder-house. The "glass" is painted blue. Could this have lasted for nearly 150 years or is it a later affectation?
[All photos by Paddy O'Sullivan]

There are presently two powder-houses. One is located on its northerly shore and is used nightly to lock up a gaggle of quacking ducks; the other, on the southern cliff edge is doorless and offers shelter to young calves. Both powder-houses have thick stone walls and strong corbelled ceilings, structurally they are in excellent condition. The powder house on the southern cliffs has an unusual and puzzling feature: a series arched recesses circle the house on its outside walls. These recesses had been fine plastered and carefully painted to give an impression of windows (Fig 1). This unexpected feature seems akin to hang-

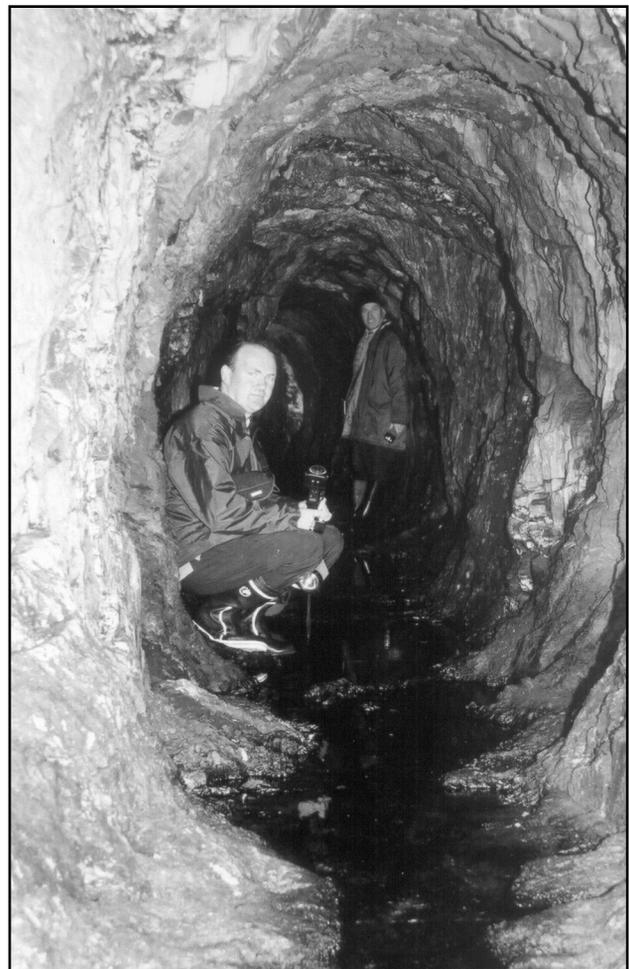
Figure 2. The adit. Tony O'Mahony in the foreground, and Michael Barry to the rear.

On looking over the cliff edge initially, I saw what seemed like a natural fissure in the rocks. Some weeks later three of us returned with a 16-foot ladder, lamps and a camera. With the aid of the ladder we were able, through a short adit (fig. 2). to enter

At the western end of the lake was a low aperture which turned into a short passage (Figs. 2,3) and quickly widened out to another cavern complex to the west. A shaft of sunlight blazing across the floor of this second stope (as it must have been) proved to be an adit which extended tunnel-like for seventy feet before emerging into daylight halfway down the cliff face and overlooking the sea beneath. This exit is not shown on the plan of 1863. However, two lodes are shown in the section (Fig. 6) so it is possible that the two stopes worked on each of them. This western stope measures eighty-eight feet in length and varies in width. There is evidence here of the mine waste being carefully stored (fig 8). Contemporary accounts mention the hardness of the rock and this is borne out by the large expanses of ceiling without the support of pillars. This stope also contains a round hole in its ceiling as though it might be a large chimney. This shaft runs upwards until interrupted by a badly decayed timber platform sitting on a few beams spanning the aperture. Its diameter is about six feet. This is what is shown on both plan and section as the western shaft but there was no sign of its extension downwards to the now submerged twenty-fathom level. Possibly what we had seen in the eastern stope was the link downwards.

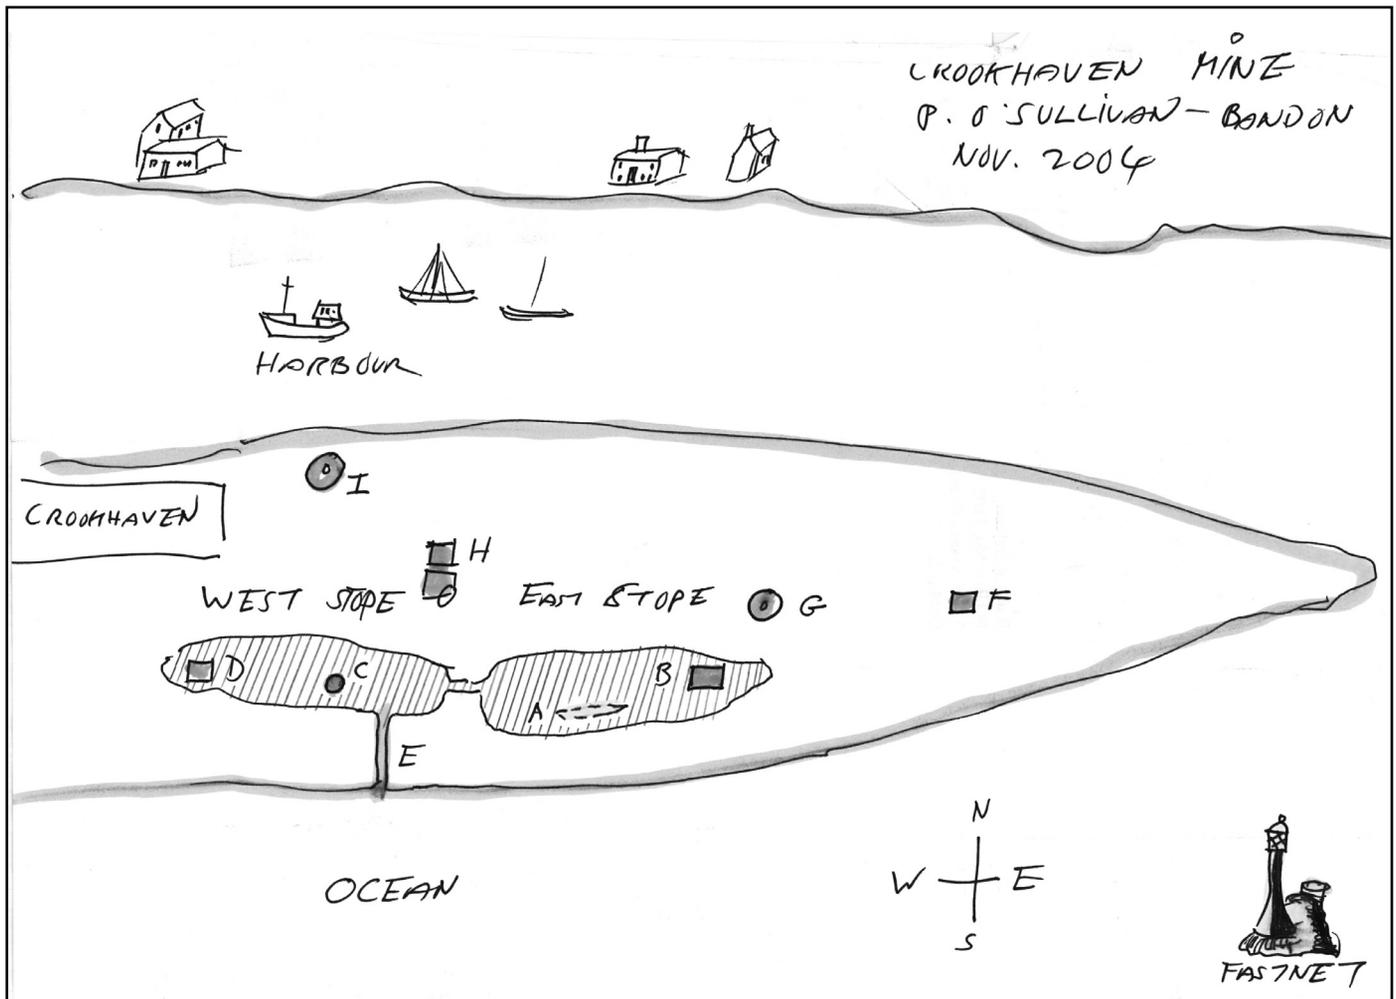
Figure 3. A sketch plan made by Paddy O'Sullivan in November 2004.

A A fissure on ceiling of eastern stope which allows entry by use of fifteen foot ladder.

B A timber framed shaft going down, this shaft is flooded and lies in about four feet below the surface of water in the stope.

C Looking upward one can see a round chimney-like shaft running to the surface. This shaft is spanned by tree trunks supporting planks and rubble filled from surface.

E An adit to the cliff face and the sea

F A distant shaft surrounded by double barbed wire fence and which appears to be flooded to within thirty feet of the surface.

G The southern powder house

H The main engine shaft and engine house remains. This shaft is also double barbed wired and clogged with builder's rubble.

I The northern powder house **D** Looking upward to the ceiling one can see a six foot square shaft again back-filled by surface rubble. Both ceiling shafts are no more than eighty feet apart.

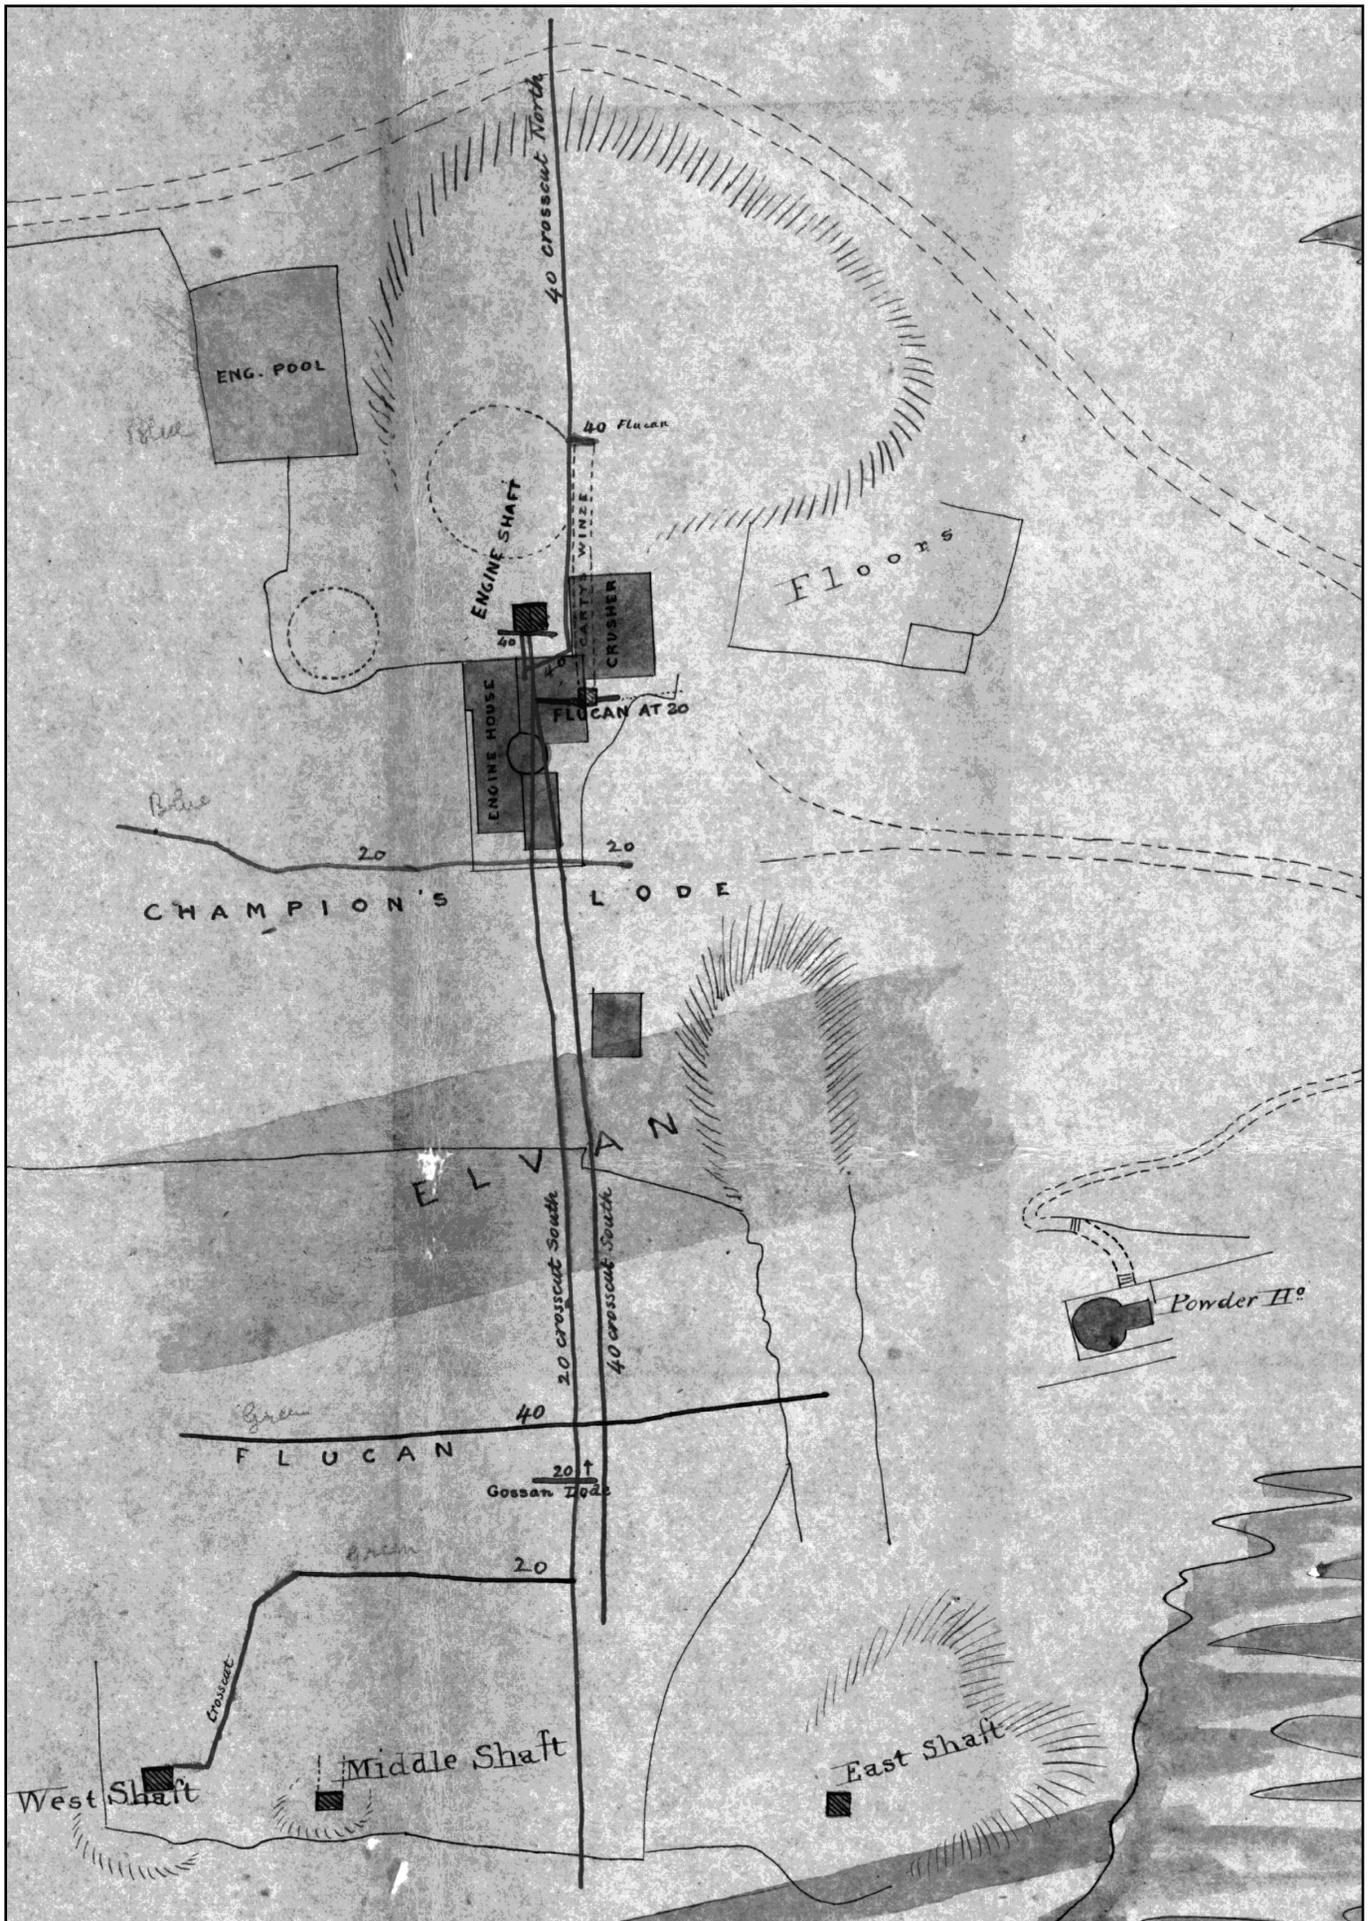
Figure 5. An enlargement of the main mine area in Figure 4

Only the inland part of this mineral exposure was known to the 19th century explorers. Returning to Crookhaven on holidays in July 2004 I found much surface evidence and more significantly a hidden adit in the cliff. I returned in the Autumn with Michael Barry and Tony O'Mahony, more equipped for exploration. Time did not allow a more detailed survey to take place. Hence this is just a preliminary report. It coincides only roughly with the plan of 1863 and section of 1883 (Fig. 5). (in Cowman and Reilly, p. 103 and 119)

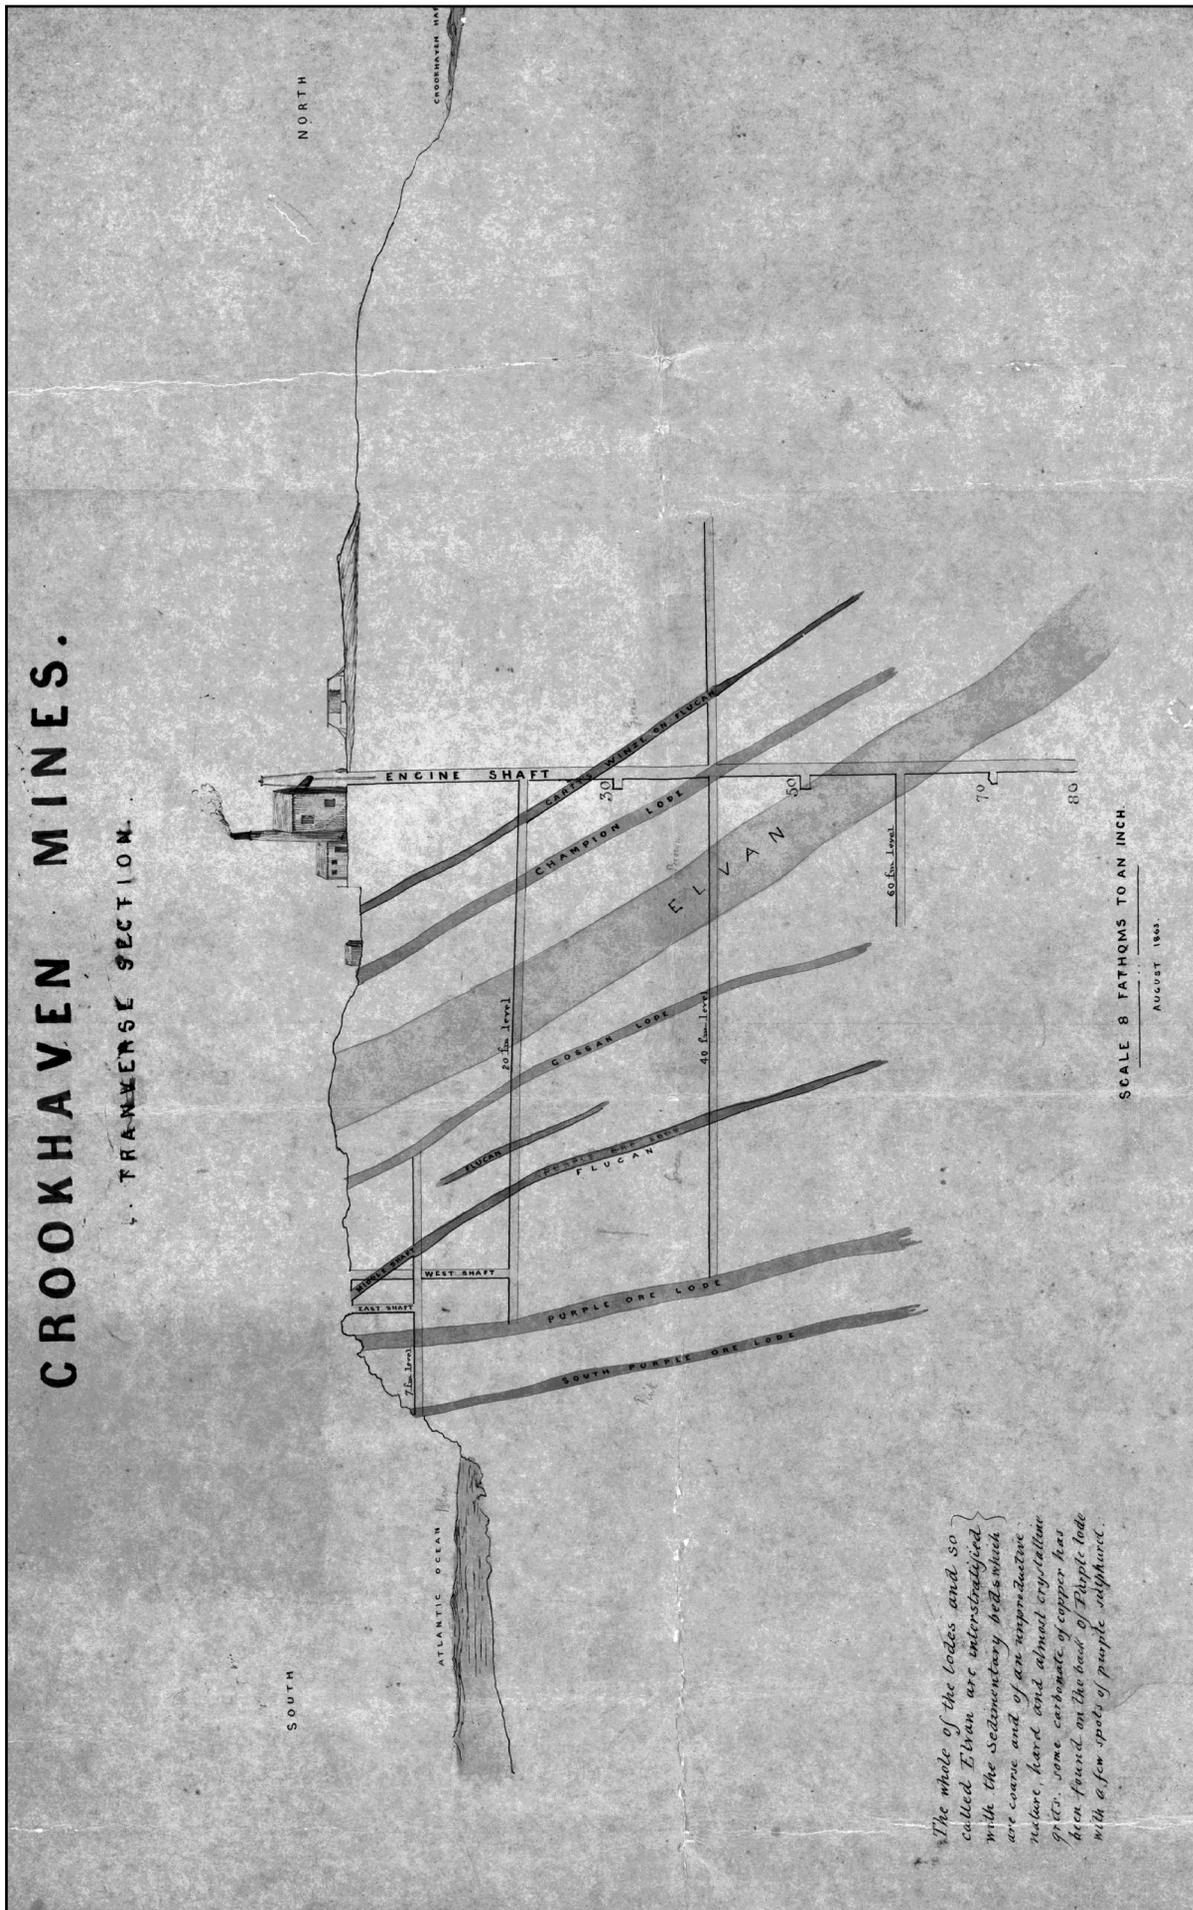
Figure 6. This GSI section of 1883 was probably based on earlier data. Only the seven fathom lode above sea level was explored. The downward connector to the submerged 20 fathom level appears to be in the western stope but in fact is in the eastern. At the lowest 60 fathom level the company predicted a conjuncture of lodes by 1864 which did not happen.

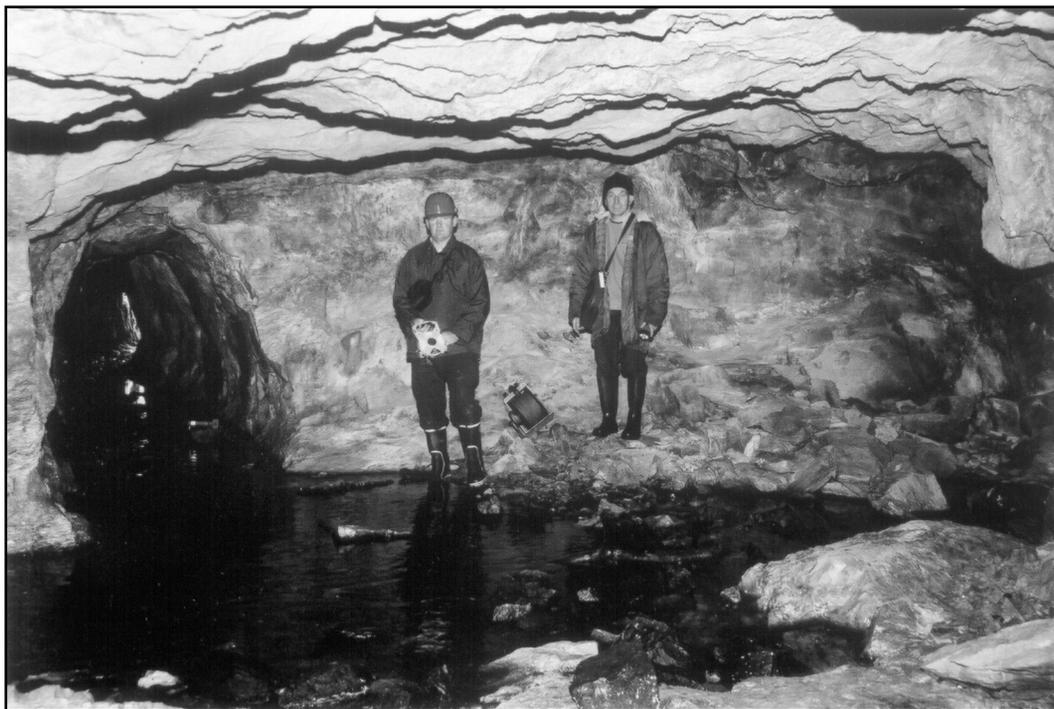
Figure 7. The western stope showing adit to the sea (E on Figure 3) on the left. Tony O'Mahony (left) and Michael Barry (right) for scale.

a large cavern-like opening estimated to be about fifty-feet long and thirty-feet wide in parts. A portion of the "cavern" (presumably a stope) floor dipped under a lake of water forty-feet long and eight-foot wide which was gin-clear and had an average depth of four-feet (Fig. 7). At its eastern end was a submerged timber-framed shaft heading downwards. This is not shown in the section of 1883.

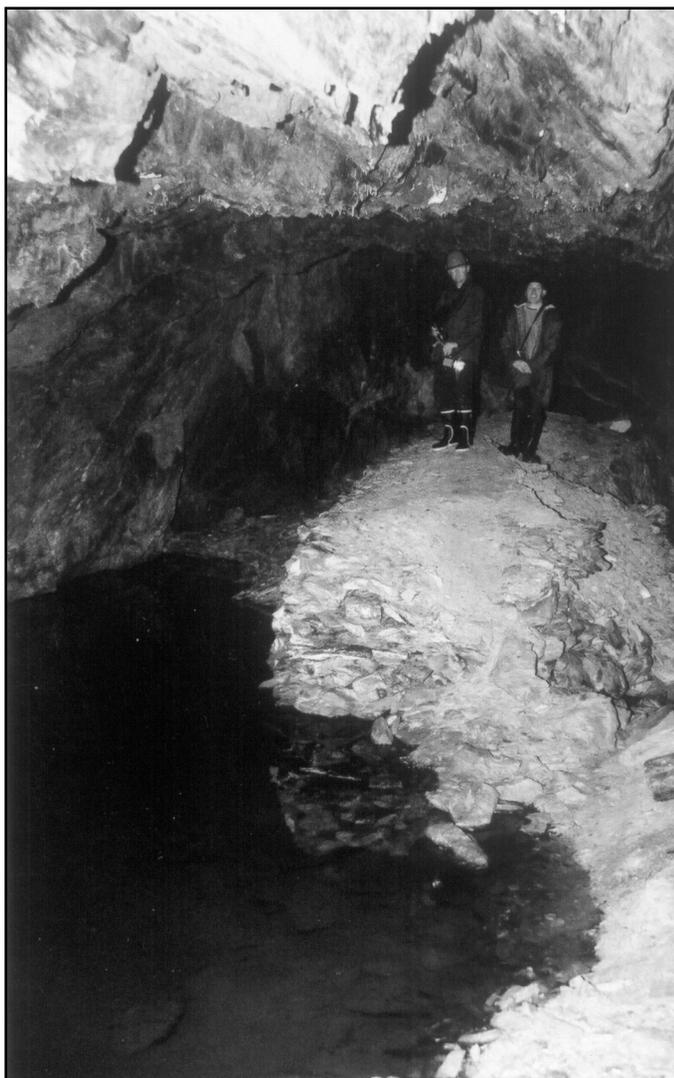
Figure 8. The western stope. Tony and Michael are standing on carefully assembled mine waste.

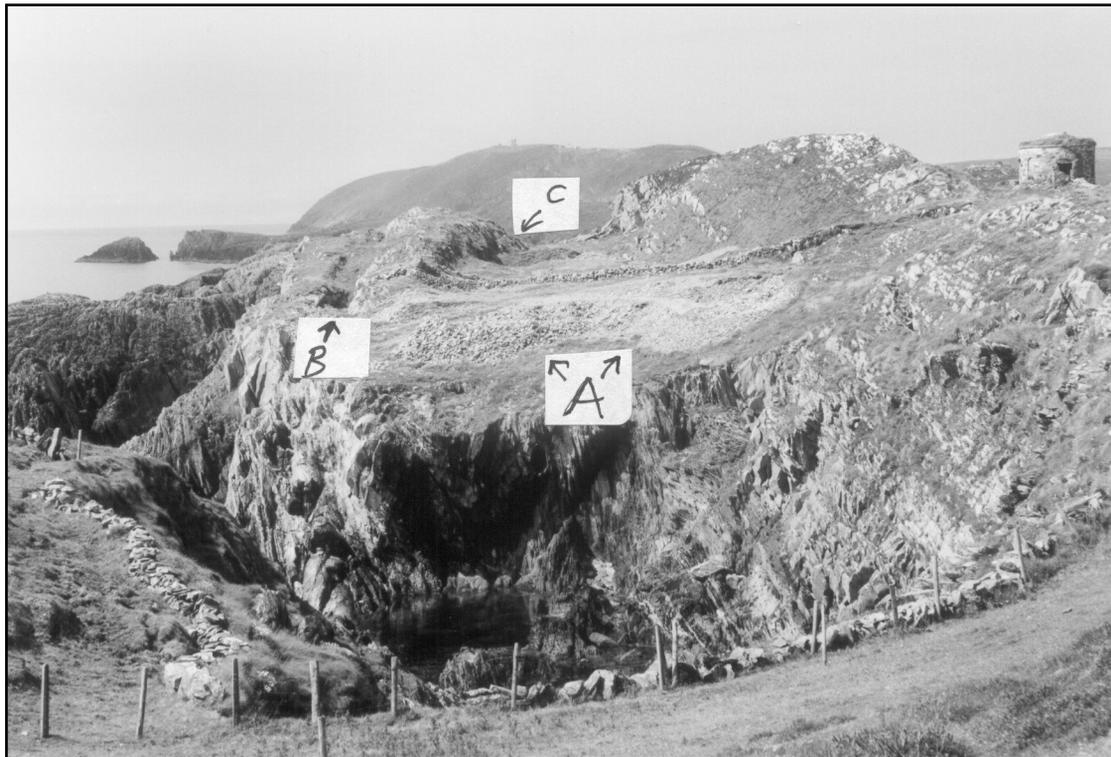
Figure 9. [left] A view

*A: piles of broken stones
B: Early working not explored
C: Low walls*

Between the southern powder house and nearby cliff edge, there are piles of broken stones - all bear jagged edges as if broken by hammer, they may have been rejected in the mine's ore-grading process. To the west are signs of waterways and at least two hand-dug sumps of swimming-pool proportions. Perhaps surface water was gathered for the boiler or to grade ore.

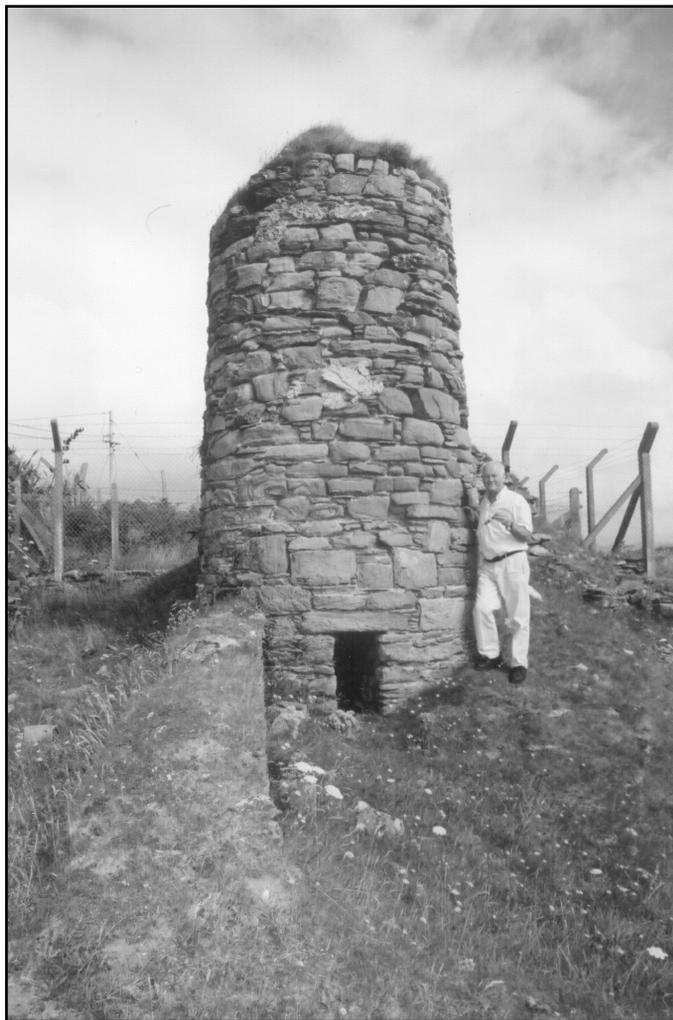
Figure 10. Remains of chimney and walls. The author for scale.

Half way between both powder houses stands the remains of an engine house and a portion of its chimney stack. The pumping shaft is again fortified with a double barbed wire fence and appears to be filled with builders' waste to within perhaps thirty-feet of the surface. The section shows this as going to a sump of 110 fathoms (660 feet) with levels off it at 20, 40 and 60 fathoms (Fig 6). This last was exploratory only and probably reflects the failure to hit a supposed juncture of lodes in the early 1860s.

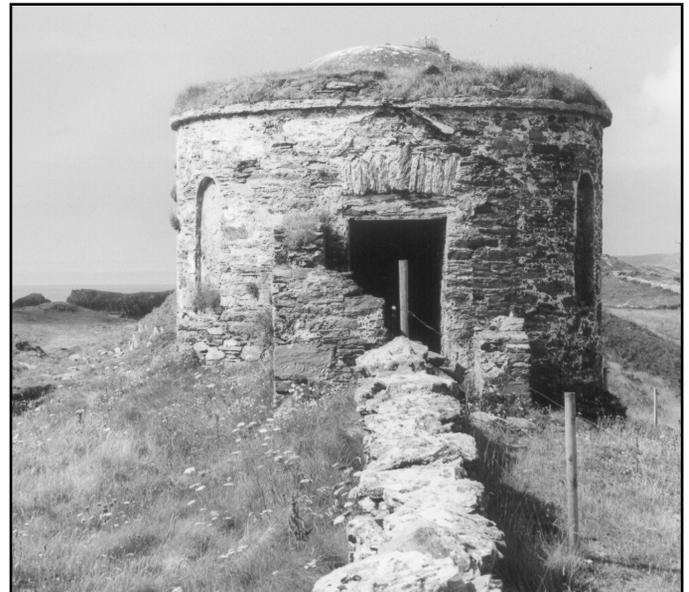
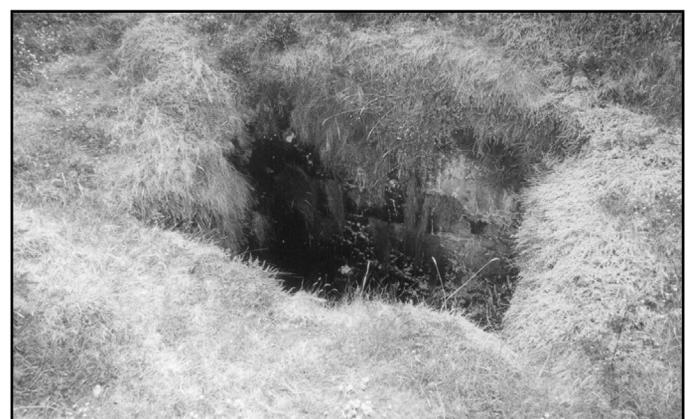
Figure 12. Shaft near a mound of broken stones, filled with rubble to five feet of the top.

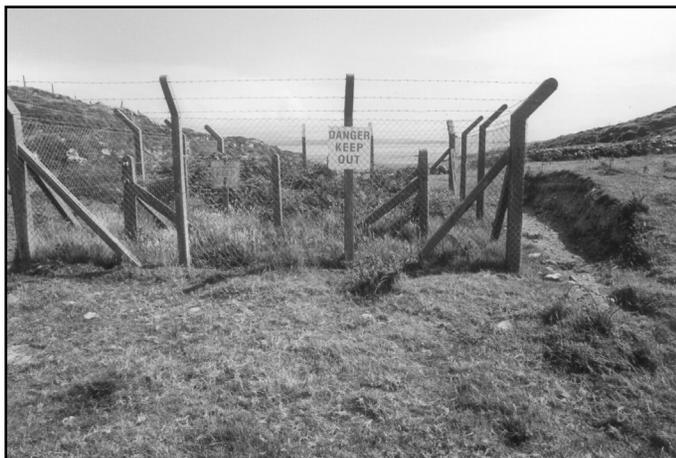
Figure 13 [top left] The eastern shaft, flooded.

visible. However, a few hundred yards east of the stopes and in an inland location there is a mine-shaft which seems to be flooded to within twenty feet of the surface. A double layer of barbed wire fencing protects the area. This does not seem to correspond to any of the known workings and may represent an earlier or later trial.

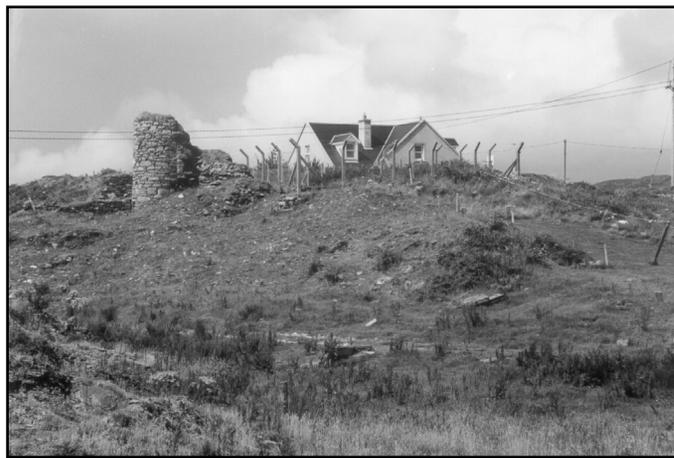
Figure 14 [top right] The remains of chimney and beam wall on northern side of peninsula.

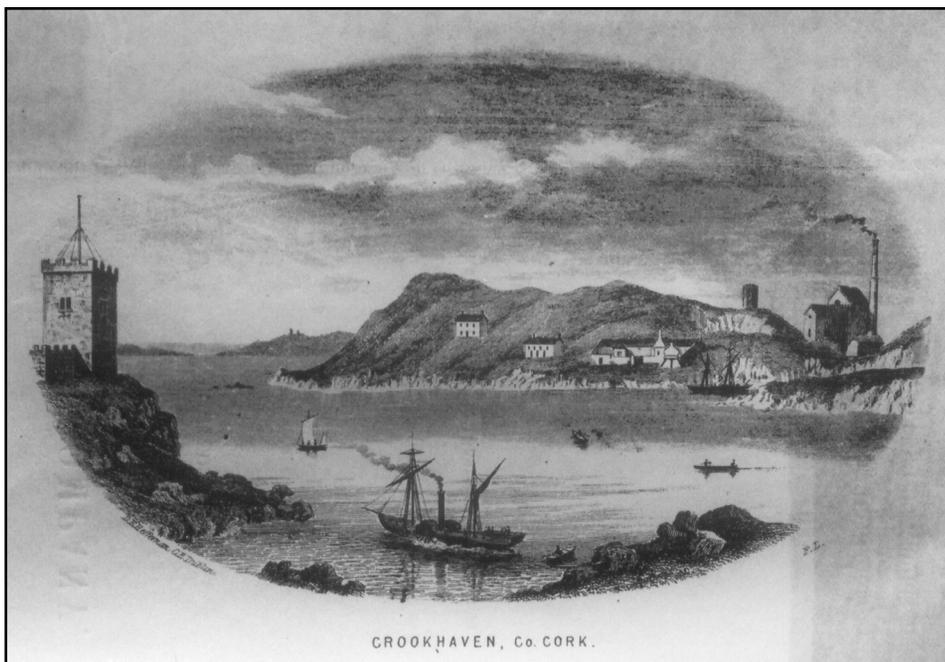
Figure 15 [left] A contemporary image of Crookhaven showing the mine engine house in operation [in Coffey and Morris 2002, A compendium of illustrations and descriptions of some Irish historic mine workings from rare, out-of-print publications and other sources. *Journal of the Mining Heritage Trust of Ireland*, 2, 65-75].

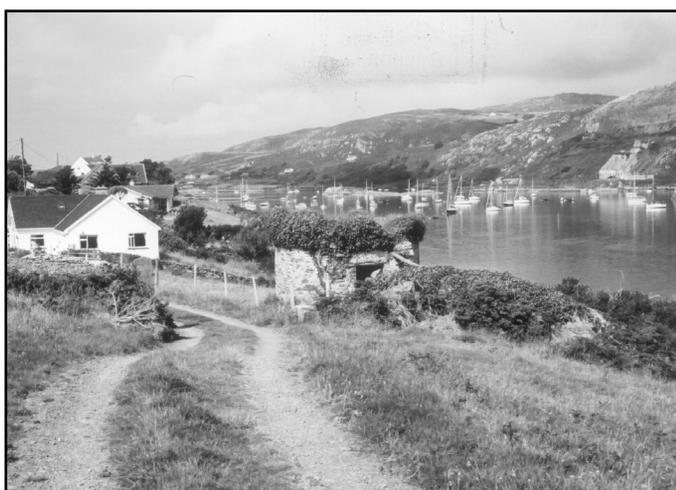
Figure 16 [below] The northside powder house.
