Morris, J. (2008) 'An Introduction to some of the Historic Mines of Glenmalure, Co. Wicklow' *Journal of the Mining Heritage Trust of Ireland*, **8**, pp. 27-38

AN INTRODUCTION TO SOME OF THE HISTORIC MINES OF GLENMALURE, CO. WICKLOW

by John Morris

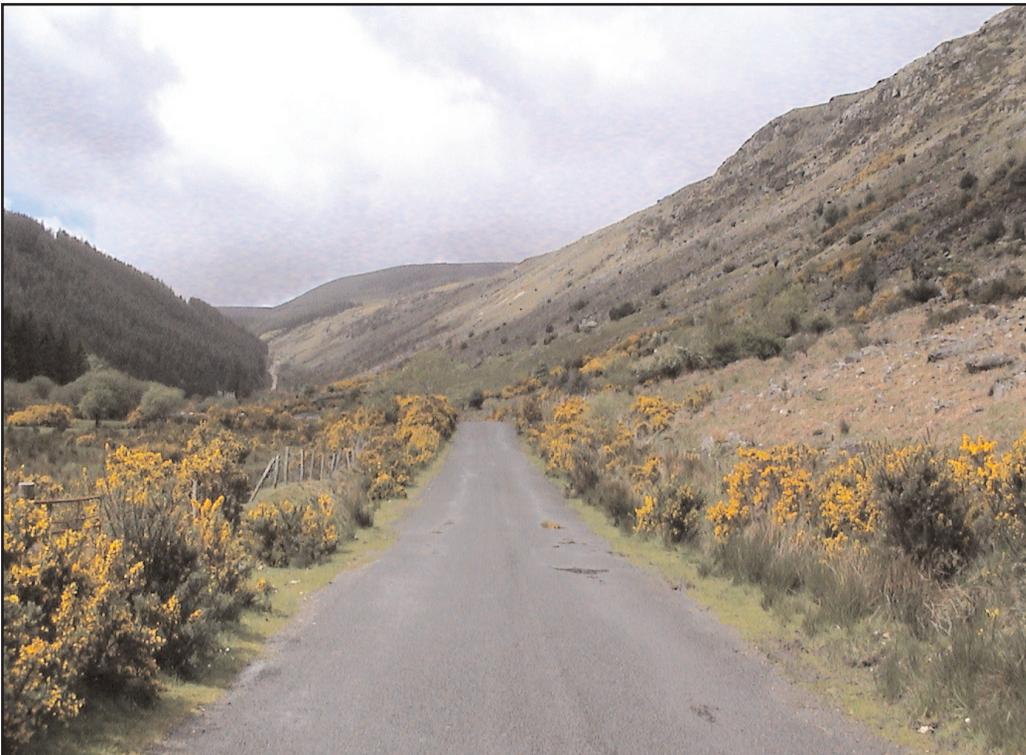
Figure 1. A general view of Glenmalure, looking northwest from a location about 500m southeast of the ford over the Avonbeg river. The Ballygoneen mine spoil heaps are just visible in the mid-distance, about half way up the right hand (northeast) side of the glen. All photographs throughout by John Morris.

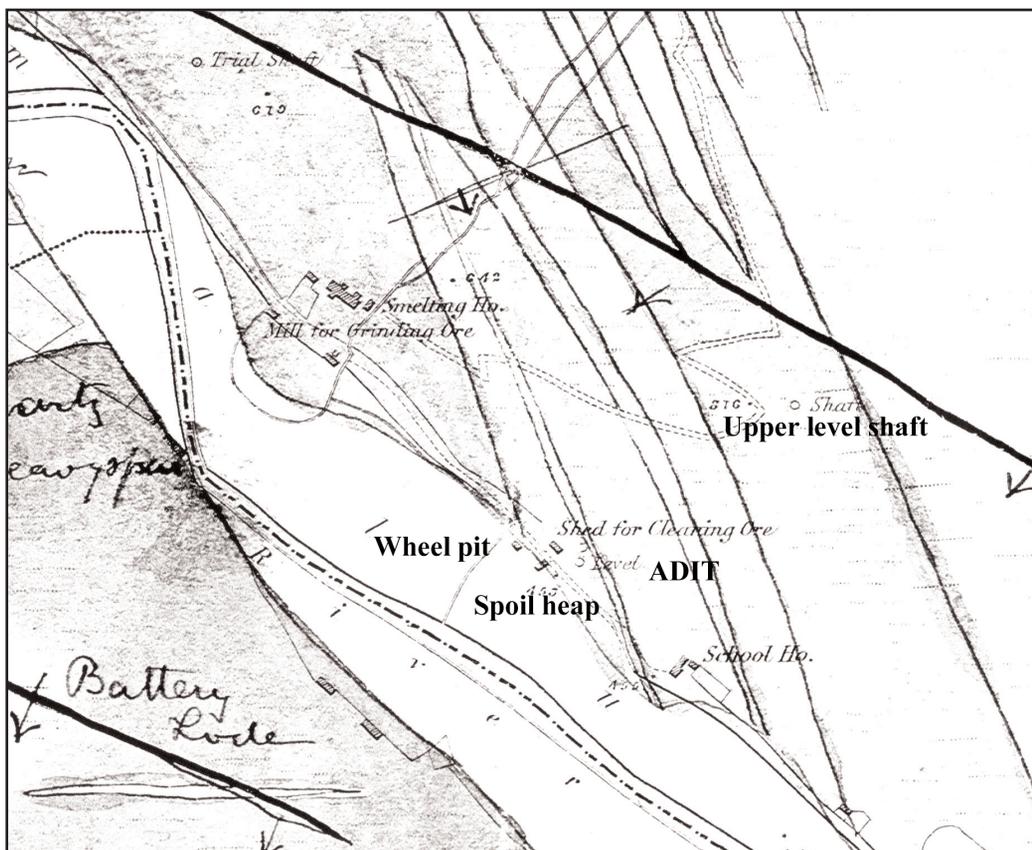
Figure 2. An enlargement of the c. 1865 Geological Survey of Ireland 6" : 1 mile scale field sheet, showing the principal features of the Ballyfunshoge Mine: smelting house complex; the main adit, spoil heaps and processing features; and the school house. The two thick lines show the surface trace of two of the principal ore veins: the Ballyfunshoge lode at the top right, and, on the opposite side of the Avonbeg River, the "Battery lode", presumed to be one of the veins worked in the Clonkeen Mine.

The Ballinafunshoge mine site is the first obvious site of its type encountered when driving northwest along the cul-de-sac road from the Laragh-Aghavanagh/Rathdrum-Glenmalure cross roads beside the Glenmalure Inn. At a point about 2.5km northwest of the crossroads, extensive, pale creamish white, largely unvegetated spoil heaps are visible on either side of the road [Figs. 2 and 3]. The mine site consists of several discrete, but separate features: the principal ore extraction and processing site, the site of a nearby school house about 100m to the southeast, and about 300m to the northwest, the site of a lead smelting complex [Figure 2].

The topographic base map of the GSI field sheet shows a school house about 100m east of the processing site [Figure 2]. Whether or not this was in any way connected to the mine, is totally unknown, though its proximity suggests that it might have been. There is now little obvious evidence of the school building, other than an embayment into the hillside, a rectangular depression and partial remains of a wall foundation [Figure 7].

The c. 1835 map of the area shows a smelter house and ore grinding mill located separately from and about 500m NW from the ore extraction and processing site [Figure 2]. There are now very few visible remains of this complex, the last remnants of which were apparently cleared as recently as about 10 years ago to make a car park and adjoining camping ground. What is presumed to be at least part of the wall foundation footprint of the principal building at this site may just be discerned as a low masonry wall around parts of the car park [Figure 8], although there is now no obvious expression of either of the other two buildings which once existed at this site. Immediately opposite this site, and right beside the road, it is just about possible to discern the roughly rectangular, but heavily overgrown outline of the ore grinding mill, and beside it a bare patch of soil in which pieces of smelting slag are still evident [Figure 9]. Peat was apparently used as the fuel for smelting (Cole 1922/1998). Nearby, and partially overgrown by forestry, it is possible to discern the outline and part of the course of the leat system, which loops around the site and back towards the stream which flows under the road, just to the southeast of the car park.

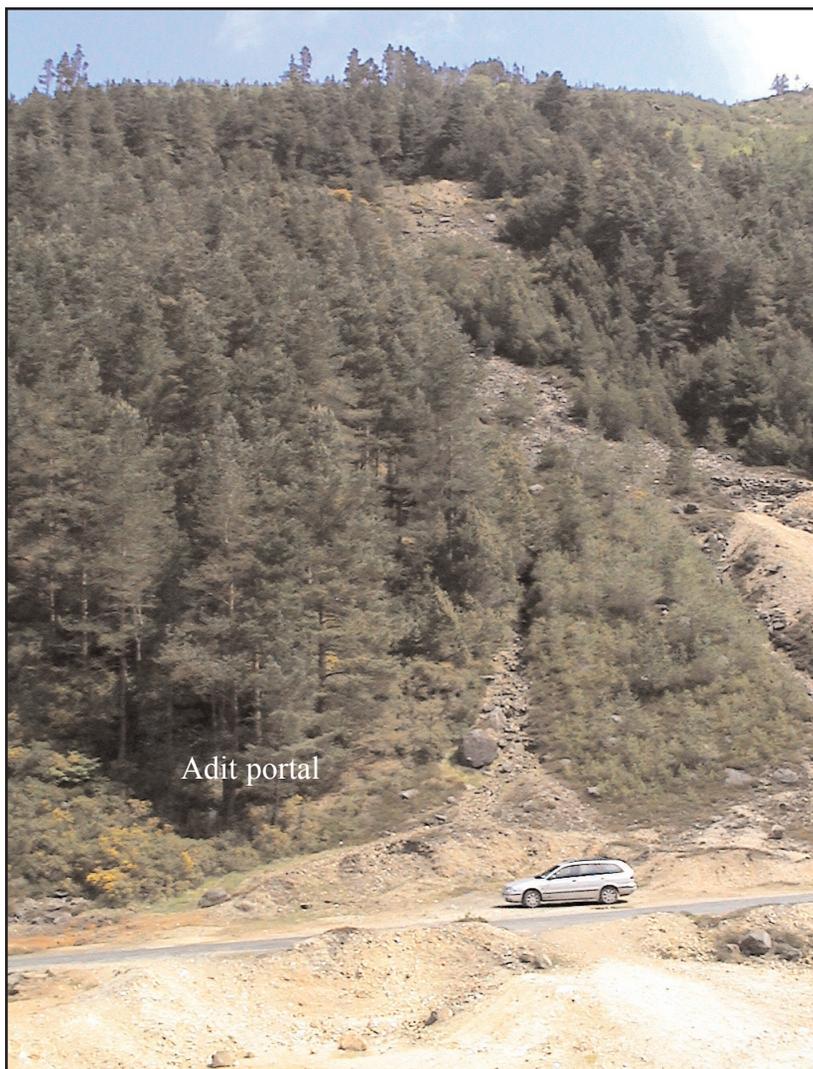
Figure 3. Left. Ballyfunshoge, showing principal mine workings.
Figure 4. Above. Ore vein structure at the end of the 25 fathom level (from Smyth 1853)

- The run-in adit portal, with active drainage creating an ochre precipitate in the drainage channel either side of the road [Figure 3];
- On the north side, spoil heaps marking workings from an upper level shaft, and, perhaps, from an intermediate level [spoil between shaft and adit, Figures 2 and 3];
- Overgrown foundation footprint of a c. 5 x 10m building, which accords with the location of that indicated on the map [Figures 2 and 5]
- Remains of a c. 1.5m wide x 8m long, masonry construction water wheel pit, which is aligned with a shallow depression, probably marking the course of the spillway down to the Avonbeg river [Figure 6]. The position of the wheel pit and inferred spillway aligns with a channel shown on the topographic map of the site [Figure 2]. The function of the water

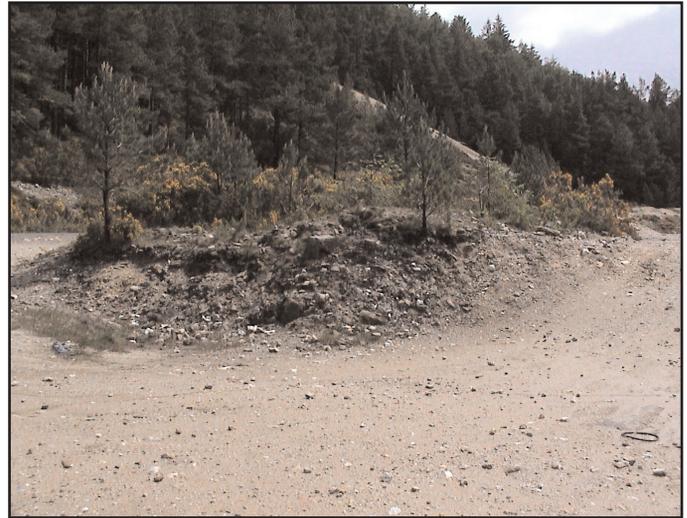
Figure 5. *Foundation level building ruin, adjacent to the road, immediately behind. Water wheel pit, to the right [see Figure 6].*

wheel is unknown, though it might reasonably be surmised to have operated a stamps mill or some other form of ore crushing machinery. This may have been located where the foundations of another construction run parallel to the long axis of the pit, about 3m to the east. It is very noticeable that the extant spoil is generally much finer in the area to the west of the wheel pit, than it is in the larger heaps to the east: this may indicate that the crushing and ore picking processes were located in and around the wheel pit area, with the coarser waste discarded to the east. The finer spoil may represent buddle waste material, although there is no obvious evidence of buddles in this area.

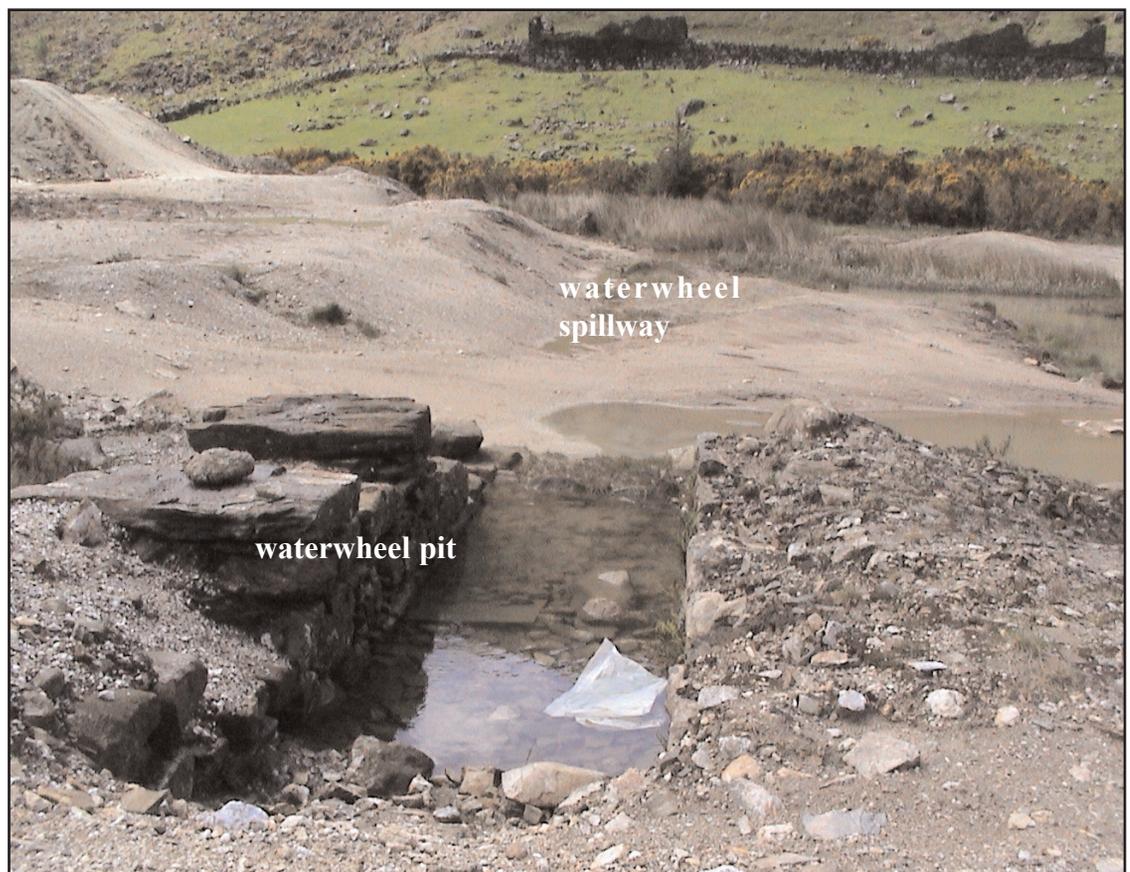
Figure 6. *Waterwheel pit, with presumed axle bearing blocks at the top of the low wall on the left; and the presumed course of the spillway marked by a linear depression in the area beyond. Note the building ruins in the background, on the opposite side of the Avonbeg river.*

There are two prominent building ruins opposite the spoil heaps, on the south side of the river [Figures 2, 6]. Both buildings are constructed on a substantial masonry base, which forms part of a walled enclosure between them and the Avonbeg river. It is presently unknown if either or both buildings bore any relationship to the mine, though proximity again suggests a possible relationship.

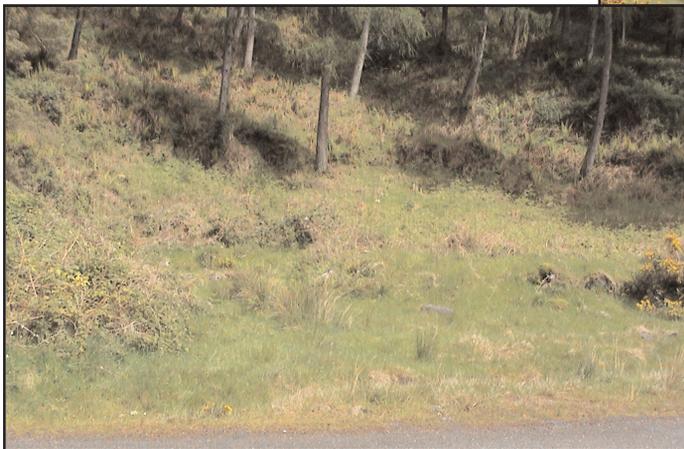
Figure 9. Right. Site of the ore crusher building marked on Figure 2, adjoined by a bare patch of soil containing prominent pieces of smelter slag.

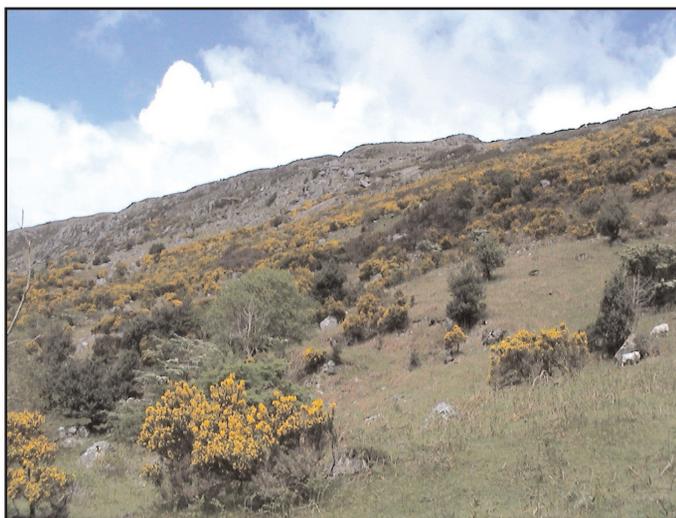
Figure 10. Cullentragh Park, general view of two very small spoil heaps (top) and a close up view (bottom).

Two small spoil heaps about half way up the northwest side of the valley, and about 900m west of the Ballyfunshoge smelter house site, mark the location of the Cullentragh Park mine (Figure 10).

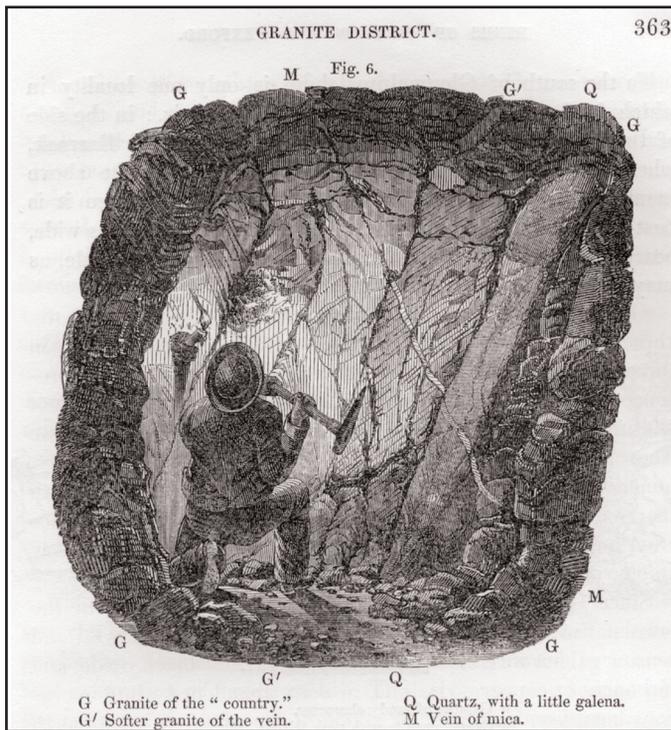
Figure 12. An 1853 engraving showing the form and method of working the ore vein in the Ballygoneen mine. Note the single candle attached to the side wall by a lump of wax: the only source of light for the miner.

He also provides a most beautiful engraving of the appearance of the ore vein, and adjacent rocks, at the working end of one of the levels, which is reproduced below as Fig. 12. He pays particular attention to a 2 inch (5cm) wide mica vein (marked M-M in the engraving), which he observed to cross cut both the ore vein as well as adjoining rocks, but in turn was cut by fractures filled with a clay like substance he termed "flucan".

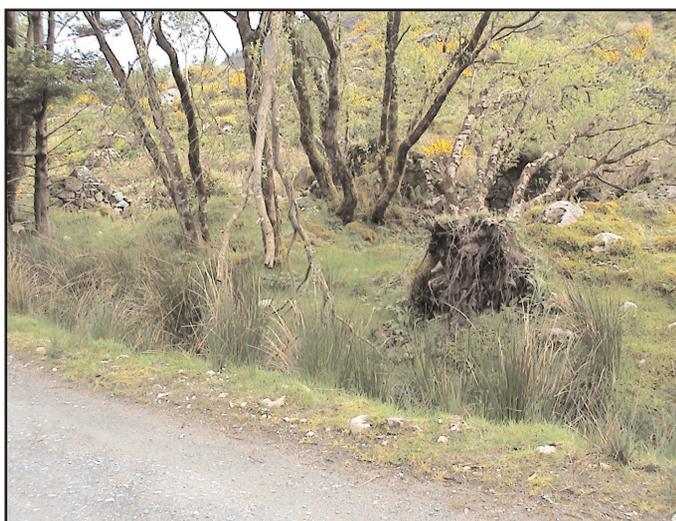
Figure 13. Low walls and foundation level ruins of two units in a terrace, presumed to be the labourers cottages constructed prior to 1859.

The foundation level remains of various small terraced buildings may be seen immediately upon the southwest side of the road, between about 50 and 250m southwest from the ford over the river (Figure 13). These are presumed to be the remains of the labourers cottages, and perhaps some of the workshops, noted in the 1859 inventory mentioned above.

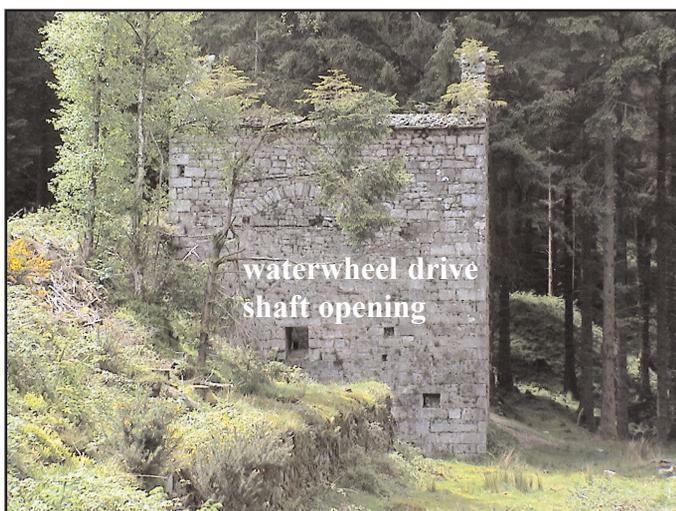
Figure 14. A view of the New Crusher House, looking west northwest. Note the prominent square opening for the drive shaft from the waterwheel (located in a slot parallel to the east facing wall visible: Figure 16) to the ore crushing machinery, which was housed inside the building. Compare with plan and section views shown in Figure 15.

There is a very noticeable difference in ground levels between the front and back of the building (Figures 14 - 16), almost certainly reflecting height requirements to accommodate the water wheel. However, a very finely constructed window/doorway located near the top of the rear elevation most likely served as the entry point for ore to be loaded into the crushing system, and the crushed material to be taken out below the crusher through the doorway at the front of the building. A miners pathway passes northwest up behind the building for a short distance, before it loops back to run southeast roughly parallel to, and above the leat visible in Figure 16. Both continue further to the southeast for about 390 feet (117m), where the leat merges into a breach in what, superficially, looks like a dam [Figure 17].

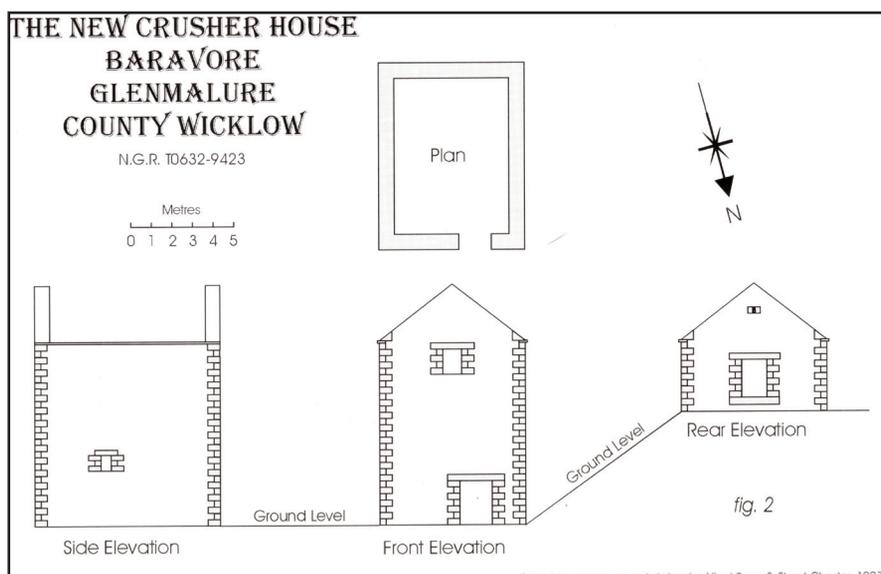
Figure 15. Plan and elevation views of the New Crusher House, Baravore (from Chester and Burns, 2001).

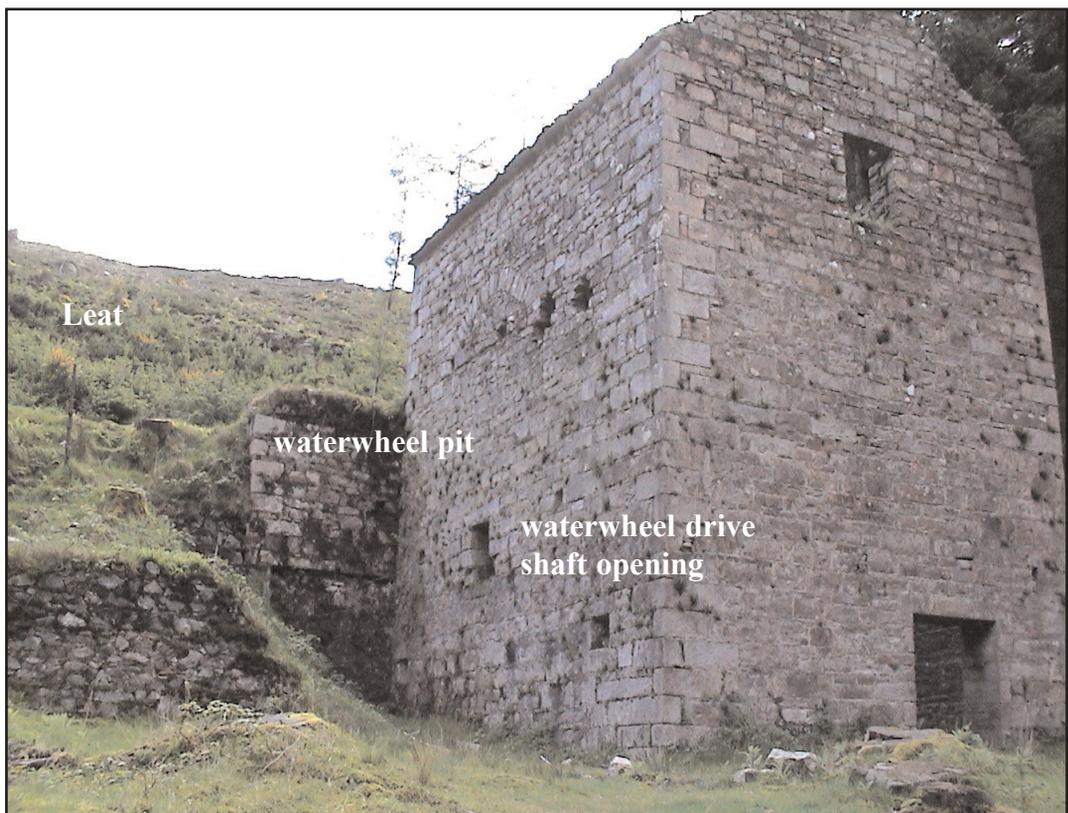
Figure 16. New Crusher House, view looking west, showing front (north) elevation and east elevation. Note course of the "leat" above and to the left of the building, the water wheel pit, parallel to the east wall, and the drive shaft opening, also visible in Figure 14. Compare with Plan and section views, Figure 15.

The dimensions of the external water wheel pit (Figure 16) indicate a water wheel up to 5 feet (1.5m) wide, and 24 feet (7.2 m) diameter. The remains of the "leat" to supply water to the wheel are still visible, though overgrown, in the area above and to the left of the wheel pit (Figure 16). The respective levels indicate that the water was most likely fed on to the top of the wheel, rather than at the side, in what is technically termed an "over-shot" configuration.

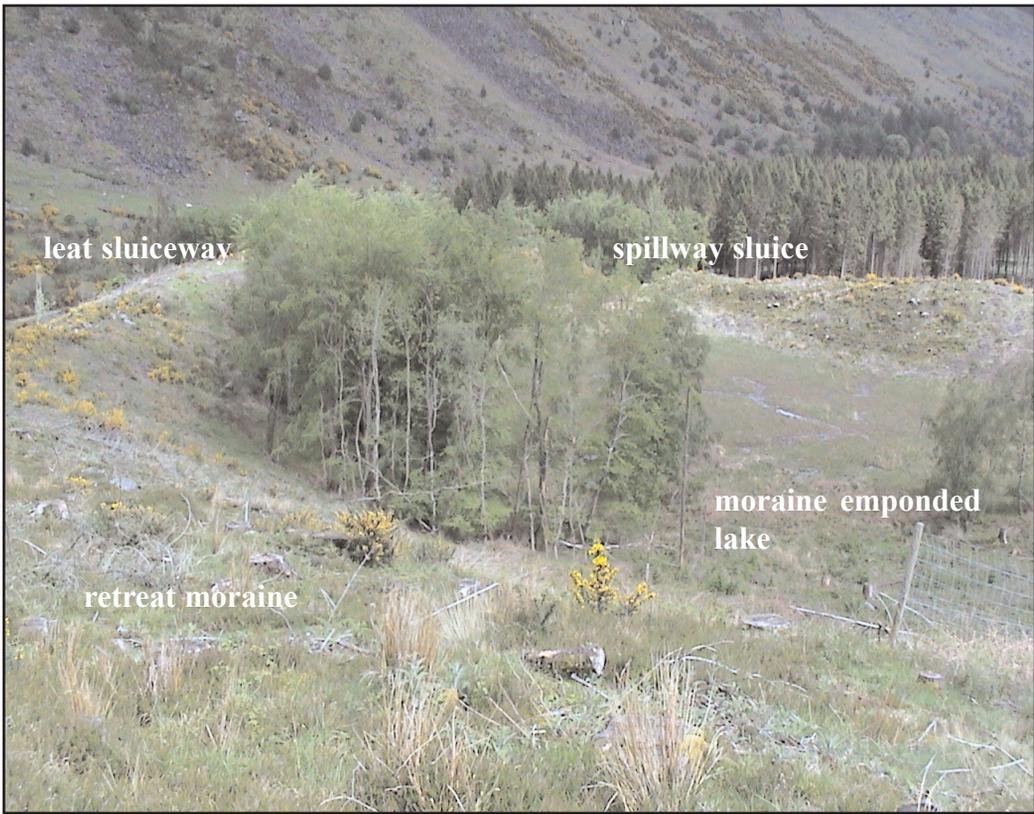
Figure 17. Retreat moraine "dam", with man made sluices, to control water supply to the "leat" to the ore crushing building; and to drain excess water away through a spillway.

The "dam" is, however, a gift of nature - in this case to a mining venture, as it is not man-made: rather it is what is known technically as a "retreat moraine". As mountain glaciers finally melted away at the end of the last great Ice Age, some 12,000 years ago, rocks, gravel, mud and clay contained in the ice, were dumped around the edge of the glacier. Provided that the edge of the glacier remained relatively static in position, the dumped material gradually accumulated into a bigger and bigger pile - to form a retreat moraine, of which the horseshoe shaped moraine at Baravore, is a splendid example.

The miners then had merely to cut a breach into the moraine and install a sluice gateway to control water entry into the leat, and, to control excess water levels, a spillway, also controlled by a sluice [Figure 17]. Water levels in the moraine emponded lake were maintained by the construction of another "leat" to bring water from the nearby Fraughan Glen into the upper, southeast end of the moraine lake [Fig.18]

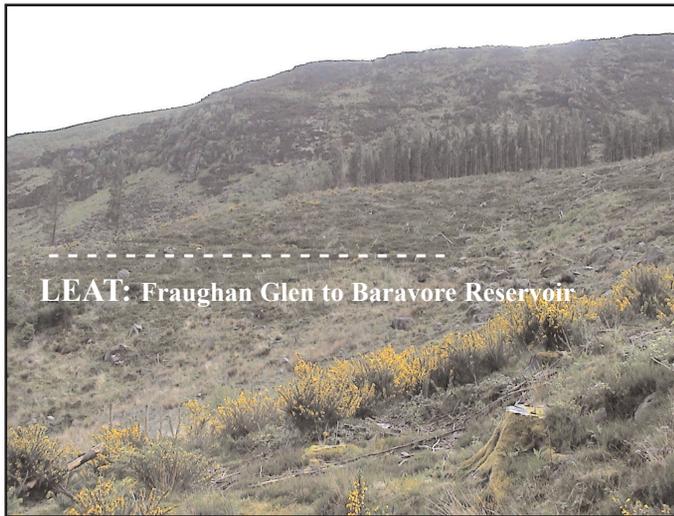
Figure 18. Water supply leat for bringing water from the Fraughan Glen to the Baravore "reservoir" (moraine emponded lake, Figure 16).

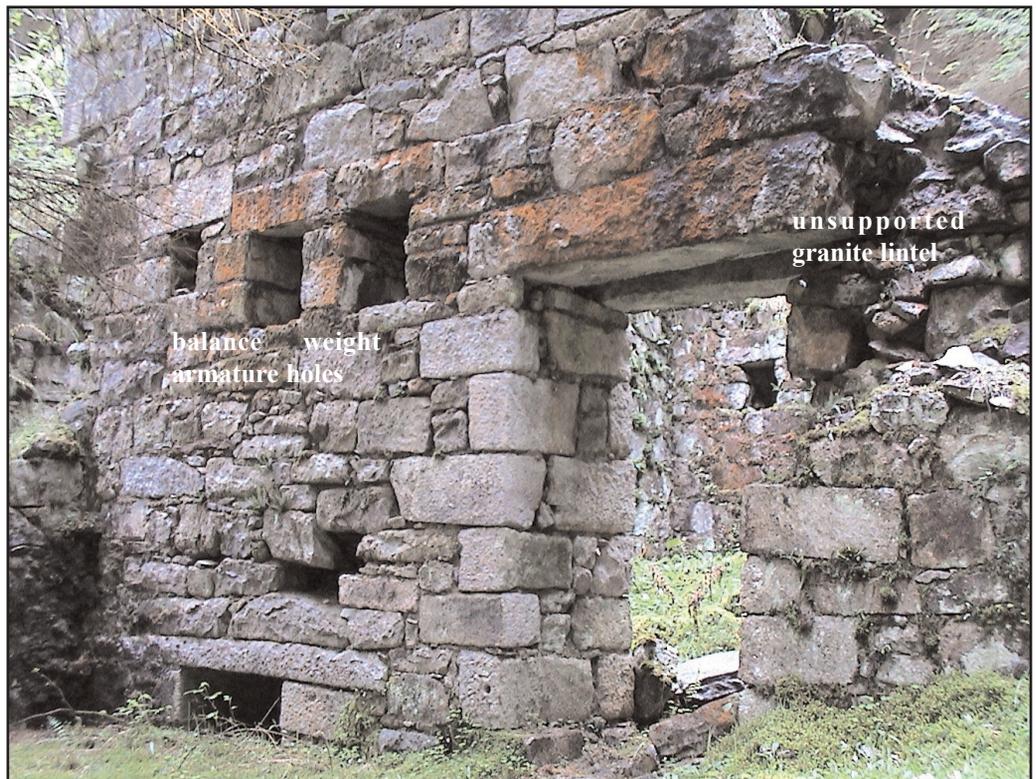
Figure 20. Below. Old Crusher House, view of southeast elevation, with water wheel pit in the foreground.

It is uncertain when the building was constructed, though it might reasonably be presumed to have been constructed during the initial phase of operations between 1846 and about 1850. The extant remains are less extensive than the "new" crusher house, and it is in a generally poorer state of preservation [Figures 20, 21].

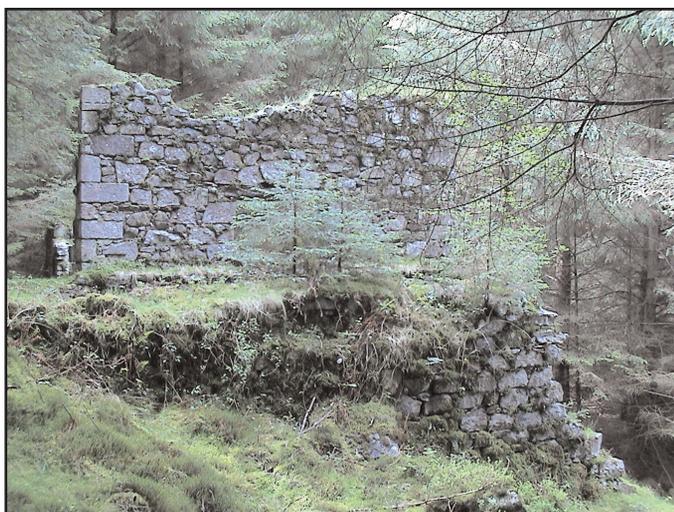
Figure 21. Right. Old Crusher House, view of northeast elevation showing partial collapse of northeast corner, unsupported granite lintel, and the two large square openings for the roll crusher balance weight armatures (cf. Figure 22).

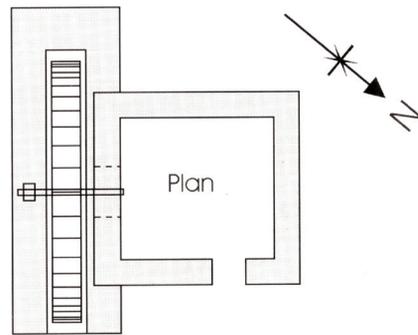
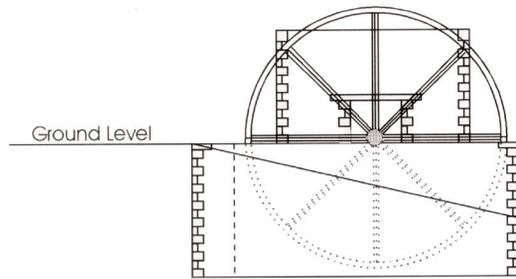
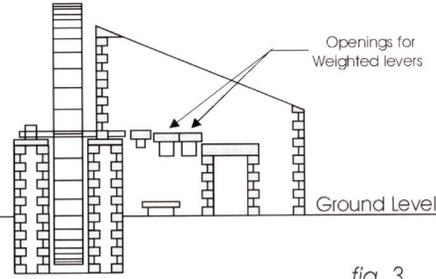
**THE OLD CRUSHER HOUSE
BARAVORE
GLENMALURE
COUNTY WICKLOW**

Figure 22. Plan, and elevation views of the Old Crusher House, including interpretation of configuration of the water wheel and ore crushing machinery (from Chester and Burns 2001).

Chester and Burns (2001) provide a detailed plan and interpretation of this building [Figure 22]. They interpret a pair of prominent square openings in the front wall (and exact counterparts in the rear wall) as the apertures through which armatures projected [Figures 21, 22]. On the exterior, each armature carried a weight which served to maintain pressure on roll crushers, as well as provide a stress release mechanism should an oversize block of rock jam between the rollers [Figure 22].

to be c.1m wide, with a diameter of c.9.5m, was located in a still reasonably well preserved pit immediately beside the southeast wall [Figures 22, 24]. The water supply was provided to this wheel [Figure 25], from a point on the River Avonbeg more than 600m to the northwest, by a very steeply inclined leat.

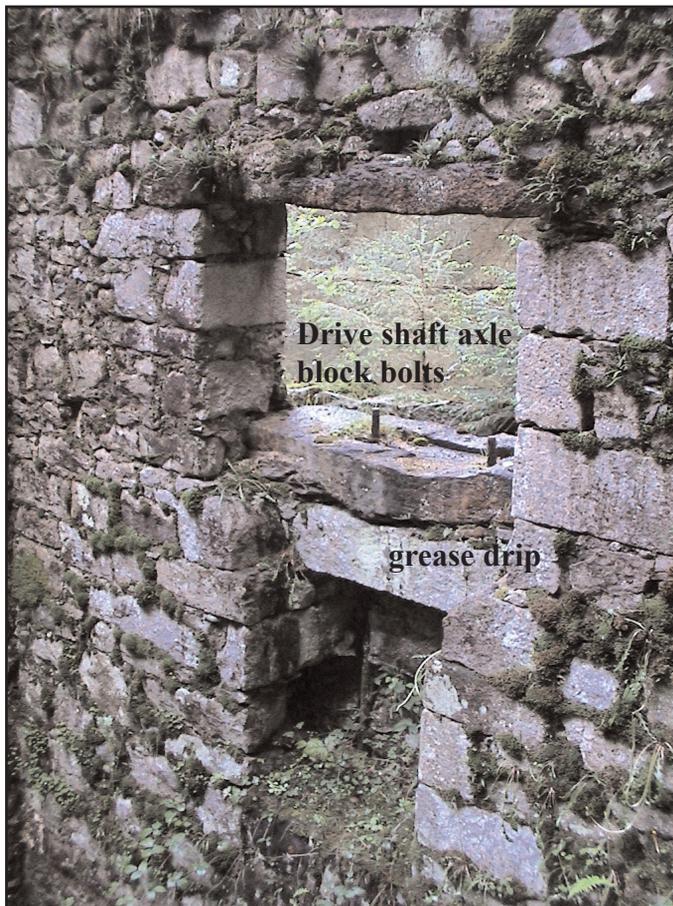
Figure 23. Drive shaft axle block bolts

As in the New Crusher House, water power drove this machinery through a drive shaft opening in the southeast wall. Axle bearing bolts and congealed grease streaks are still readily visible on the inside of this wall [Figure 23; interpretation, Figure 22]. The water wheel, interpreted by Chester and Burns (2001)

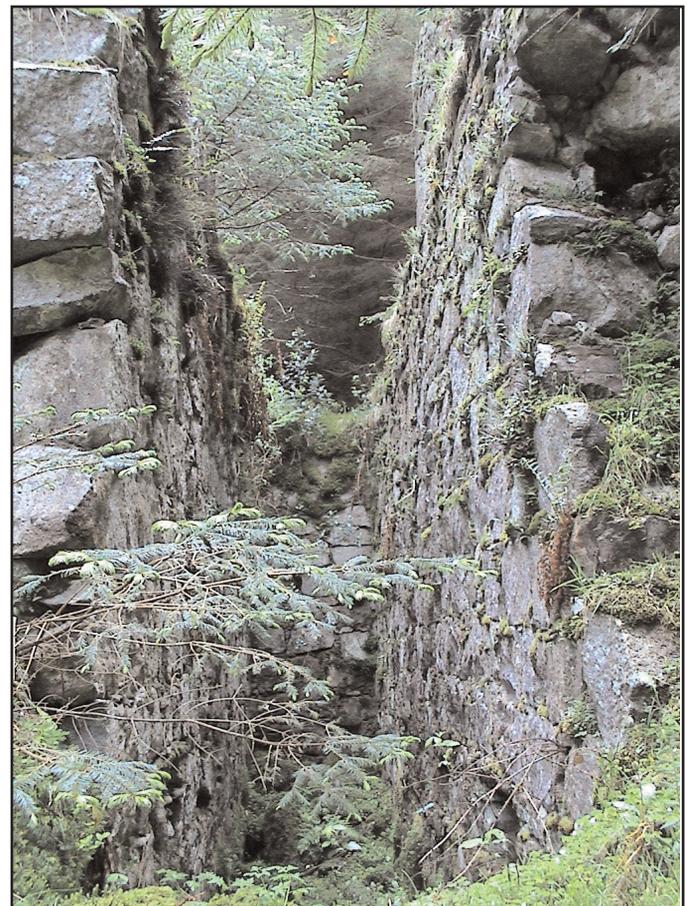
Figure 24. Water wheel pit, view looking southwest

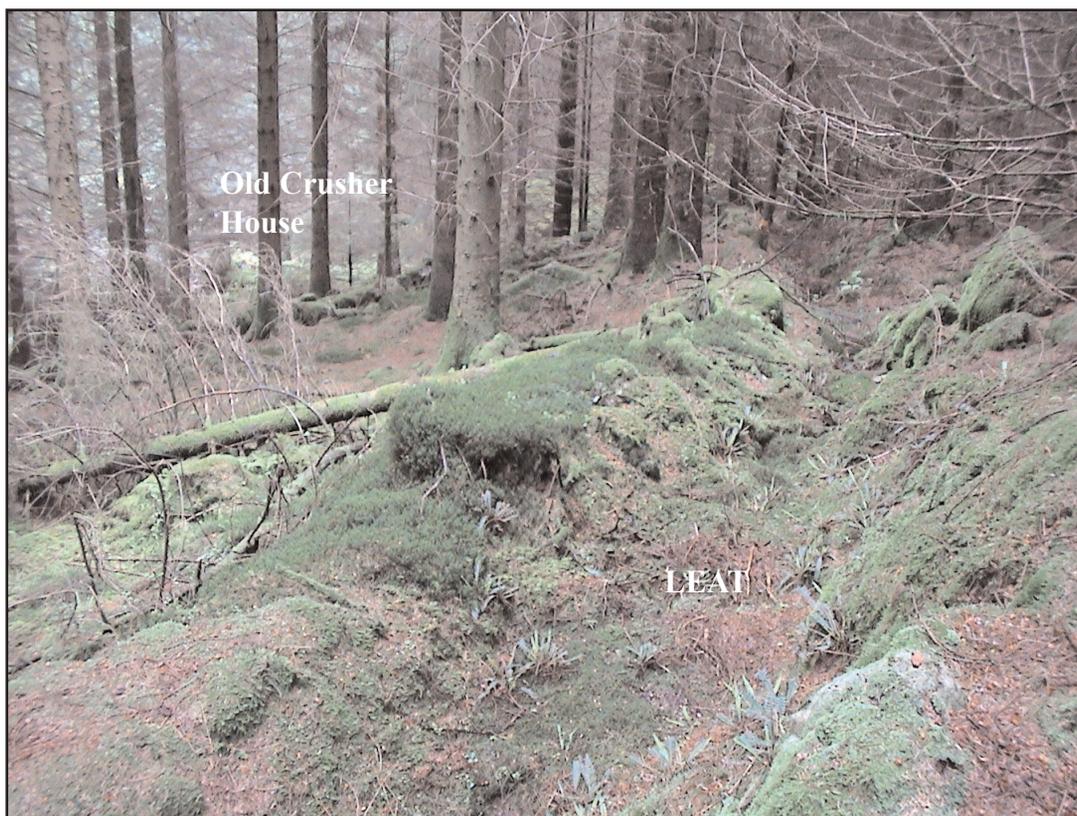
Figure 25. Steeply inclined leat from the River Avonbeg to the Old Crusher House, just visible through the trees on the upper left hand side of the photograph.
