Critchley, M., Morris, J. (2005) 'Conservation Works at Tankardstown Mine, Bunmahon, Co. Waterford' *Journal of the Mining Heritage Trust of Ireland*, 5, pp. 75-79

CONSERVATION WORKS AT TANKARDSTOWN MINE, BUNMAHON, CO. WATERFORD

Abstract: This paper records and illustrates conservation works undertaken between 2004 and 2005 on the Tankardstown Engine House complex, Co. Waterford. *Journal of the Mining Heritage Trust of Ireland*, 5, 2005, 75-79.

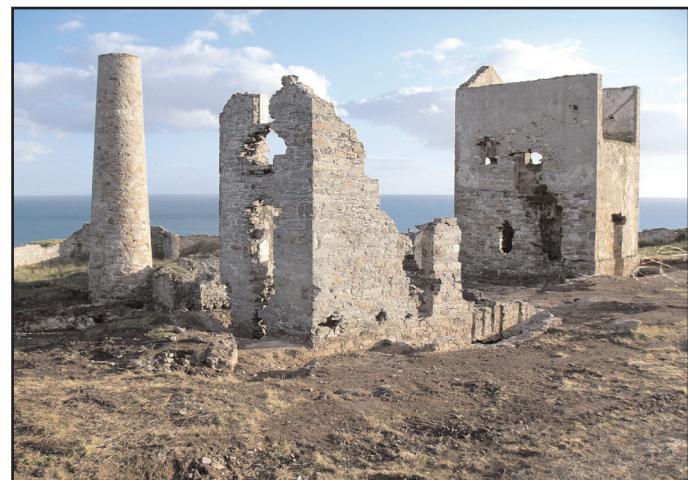
Figure 3. Tankardstown Engine House complex, September 2004, after completion of archaeological excavations, prior to conservation works. Pumping Engine house on right, winding engine house centre, and single chimney which served both boiler houses on the left.

- Rebuilding of damaged walls (mainly on the east wall where the stonework was removed when the engine was scrapped; Figs 3, 5)
- Rebuilding stonework and brick archway of rear door (Fig.7)
- Consolidation of floor (Fig. 6)
- Restoration of cataract pit and crawl tunnel (Fig. 6)
- Replacement of all wooden lintels (Figs 5, 6, 7)
- Installation of iron security grilles to all ground and first floor openings

- Rebuilding of bedstone masonry plinth, including bolt tunnel and drain channel through to rear of building
- Rebuilding masonry sections in rear wall, along with insertion of oak lintels
- Rebuilding parts of both wing walls to stabilize extant remains, including tying in an isolated pillar (Figs. 3, 10), all that remained of the wall section which supported an internal wooden beam to support the wholly enclosed beam (as at Levant, Fig. 8b)
- Sealing/ re-bedding all wall tops as needed

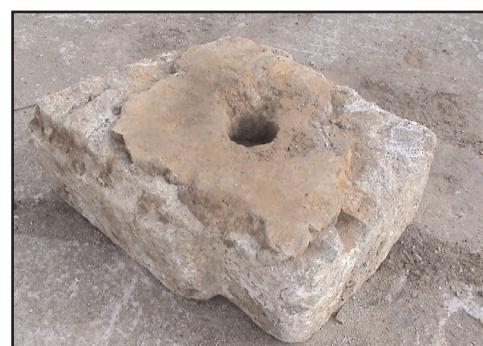
Figure 4. Left.
Bedstone fragments with ochre packing material.

The pumping engine house was built in the mid 1850s to house a beam engine which was reputed to have been moved to the site from its previous location atop the cliffs at Stage Cove (Knockmahon: Morris *et al.* 2005, Fig. 52 therein). The main shaft at Tankardstown is believed to be 164 fathoms (250m) deep, although this is presently not open to surface as it was blocked during the use of the site as a film set in the late 1960's. The main shaft was used both for pumping and for winding, with separate engines being installed for each operation. The engines were installed in the two engine houses which now remain on the site (Figs. 1, 3). The pumping engine house (Fig. 3) contained a 50", single acting steam powered Cornish beam engine, which lifted the pump rods within the main shaft. Parts of the engine bedstone remain (Fig 4). These, unusually, have an ochre coloured coating on one side, which is believed to be the remains of the original ammonia-iron filings-urine packing/leveling material hammered into position under the steam cylinder (K. Brown 2004, *pers. comm.*).

The winding engine house contained a smaller, rotary steam winding engine housed in a totally enclosed engine house, virtually identical to that at the Levant Mine in Cornwall (Fig. 8a). There are no records of the size of the winding engine cylinder but examination of the remains of the bedstone, suggest that it was a 20" engine, which Morris *et al.* (2005, this Journal) suggest may have been moved here from a previous engine house location in Ballynasissala. Very little of this structure now remains, save only the rear wall and part of one wing wall, a substantial portion of which collapsed between 1970 (when it was still visible in the MGM film "The McKenzie Break"; Fig. 10) and the early 1990s. The entire bedstone masonry plinth had been robbed out, along with the front wall and most of both wing walls (Fig. 9). Archaeological excavations, however, revealed the footprint of the boiler house on one side, the winding drum pit on the other, and fragments of the limestone bed stone.

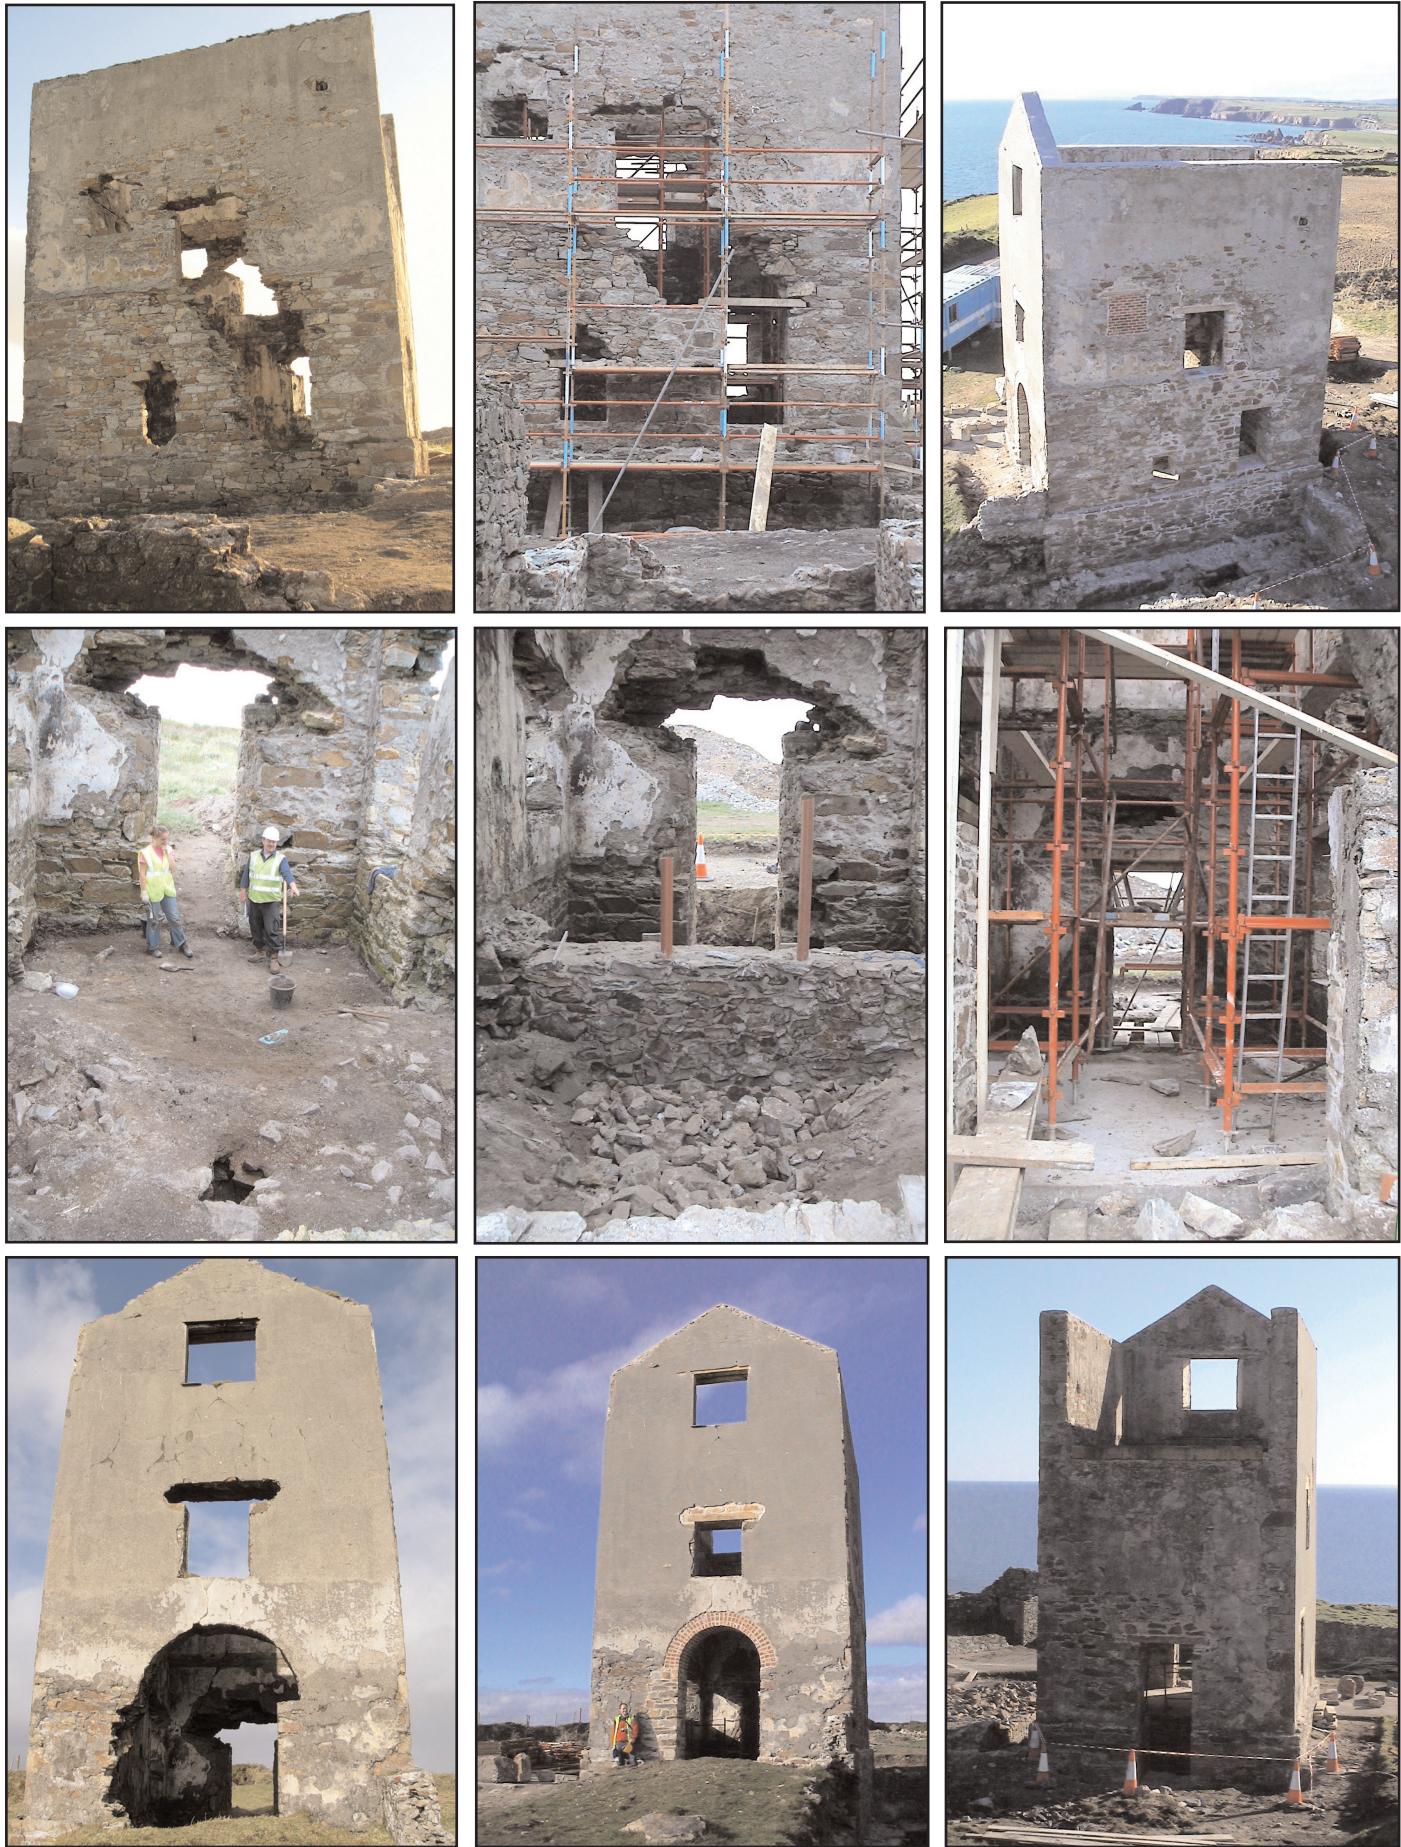
Figure 7 Bottom row: views of rear gable and bob walls: before and after conservation works on gable wall (left, centre: note reconstructed masonry and brick arch over cylinder doorway, and replaced oak lintels in windows above); and after completion of works on Bob wall (compare with views in Figs. 3 and 6 before conservation works).

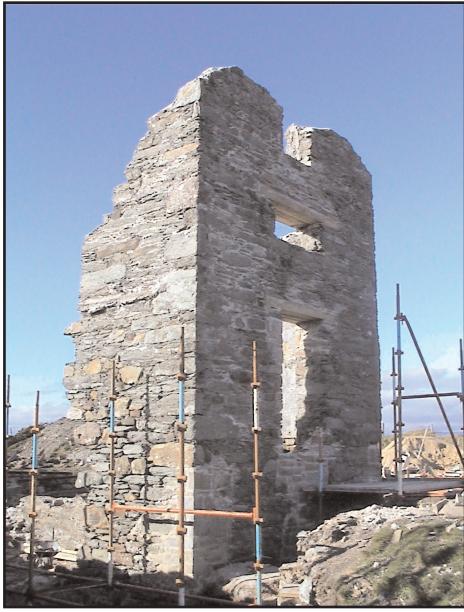
Figure 9: Above left - Tankardstown Winding Engine House, viewed from the same perspective as Fig. 8b. The original cylinder floor level was located just below the base of the internal plaster level visible above the people standing in the area of the completely robbed out cylinder bedstone masonry plinth. Note the crow hole tunnel and drainage channel located beneath the plinth. Part of internal bob beam support wall visible on right (the isolated pillar in Fig. 3). Flywheel and crank originally located along inside edge of left hand side wing wall (left foreground), and to external winding drums outside the building, on the left.

Above centre - similar view during conservation works, showing replaced oak lintels and masonry in rear wall, and reconstruction of masonry plinth, above crow hole level, in progress

Above right - external view of rear wall showing replaced lintels and reconstructed masonry sections

The conservation works undertaken (Fig. 9) were:

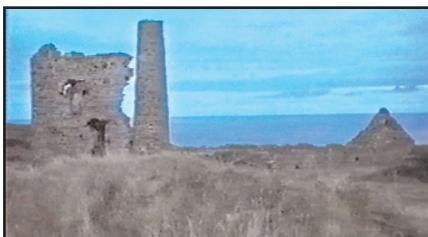
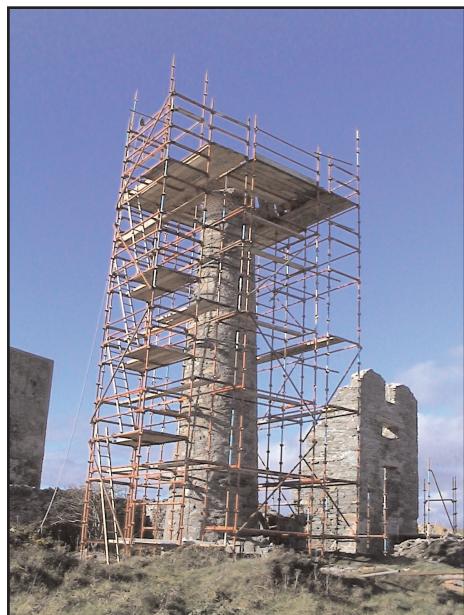
Figure 10. Chimney stack conservation and reconstruction: above, as visible in the 1970 film, "The McKenzie Break" (reproduced by permission of MGM Films); right, similar view, 2004. Note and compare the loss of part of the Winding Engine house wing wall between 1970 and 2004, and also the external winding drum pit on the nearside of the building, with prominent grooves for axle hold down bolts; far right, during reconstruction of the brick chimney top in 2005.
