O'Sullivan, P. (2006) 'The Mines of Sheep's Head and Mizen Head Peninsulas, County Cork' *Journal of the Mining Heritage Trust of Ireland*, **6**, pp. 23-36

THE MINES OF SHEEPS HEAD AND MIZEN HEAD PENINSULAS, COUNTY CORK

By Paddy O'Sullivan

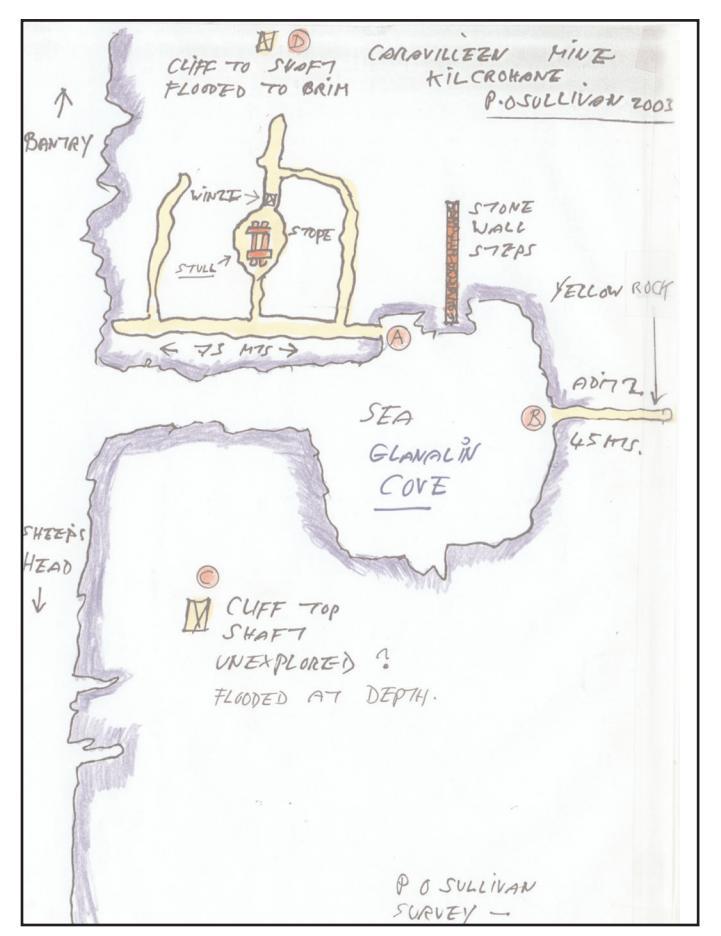
Figure 1. Sketch survey of Caravilleen Mine and Glanalin Cove, Kilcrohane, Sheeps Head Peninsula, by Paddy O'Sullivan.

These represent operations on the townlands on either side of Glanalin Cove (Fig. 1). These had been worked by a Londonbased Glenaulin and Caravilleen Mining Company, established in 1852. Operations finished in 1855 though the company maintained a paper existence until 1862. (BT -/1465). Then in 1863 a "Glan Alan" Mining Company was established, though whether they actually mined there goes unrecorded. A Glen Cove company came into existence in the 1880s (Cowman and Reilly 1988, p. 129). Associated with this were Mssrs Wood and Ewart of Lisamerig. In 1884 a Captain Chipman was in charge of operation which was said to be "Bare preliminary" .Presumably the current remains post-date this. Oral tradition of working at "Cuas, Glaun" and workings at Carravileen suggests that they closed when it was realised that there was only about 250 tonnes of copper in the mines (O'Mahony, p. 75 and 87).

At this latter mine there is evidence of more substantial mining than the stark records indicate. The only way in to the cove is by boat and Carravilleen adit is about six metres above mid tide. It runs straight for 75 metres full of puddles and twelveinch deep sticky mud that seems iron-based. Three branches run from the adit as indicated in fig. 1. Only the middle one has a stoped area with stulls (Figs. 2-4). A flooded winze indicates some lower workings and above the stulls evidence of another level and workings up towards the surface. The two northern levels from the adit end in blank walls. The most visible mineralisation is just beyond the winze.

Adit B starts about three metres above a pebbled beach. It is unusually wide and high through its 48 metre straight length and ends in a blank where the rock colour changes to a sulphur yellow. It is difficult to know what purpose this served. Two shafts (C and D) indicate that there are possible other hidden workings; most of C is dry but D is flooded to brim.

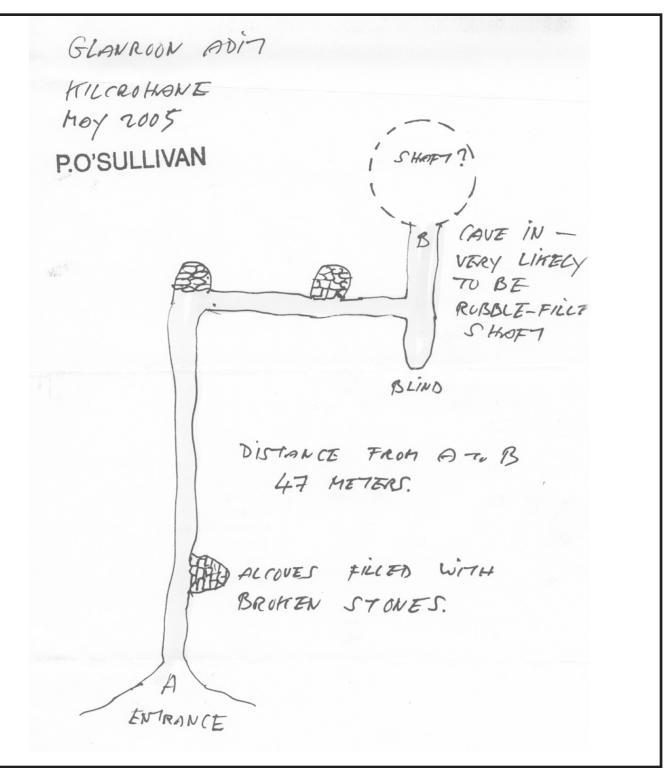
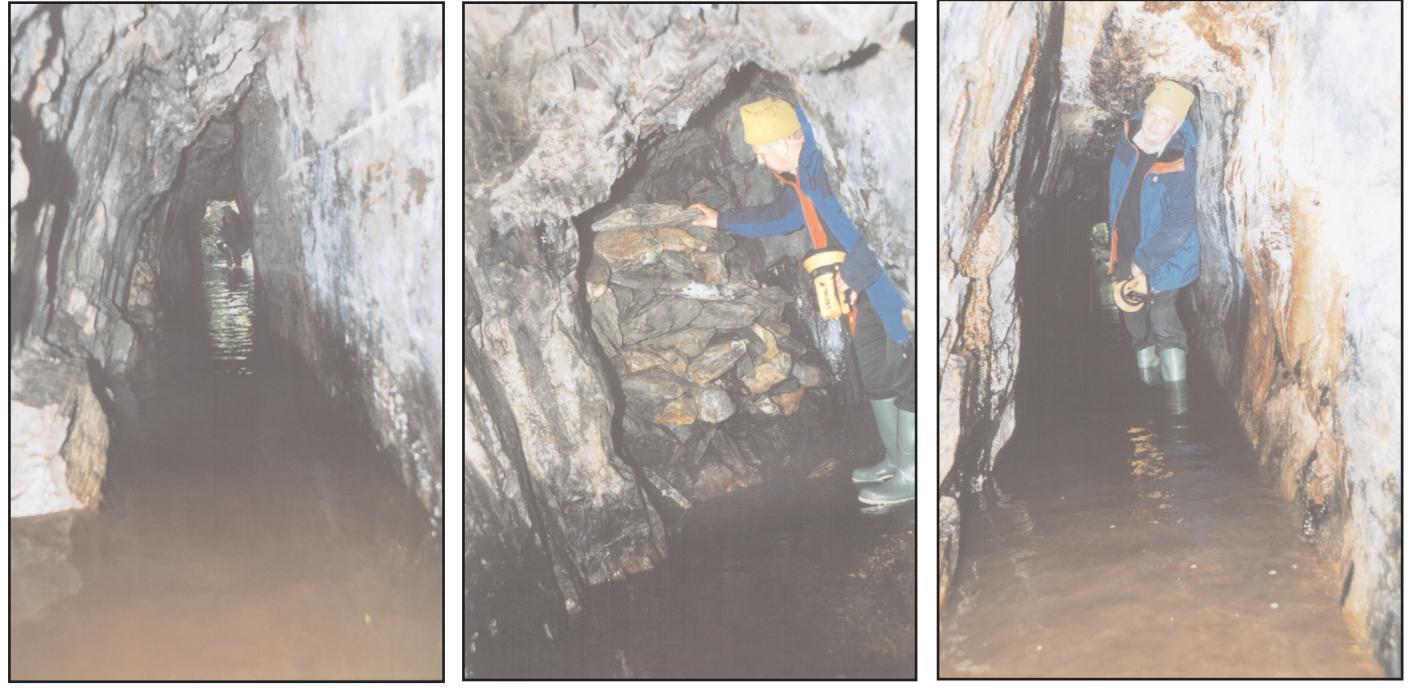
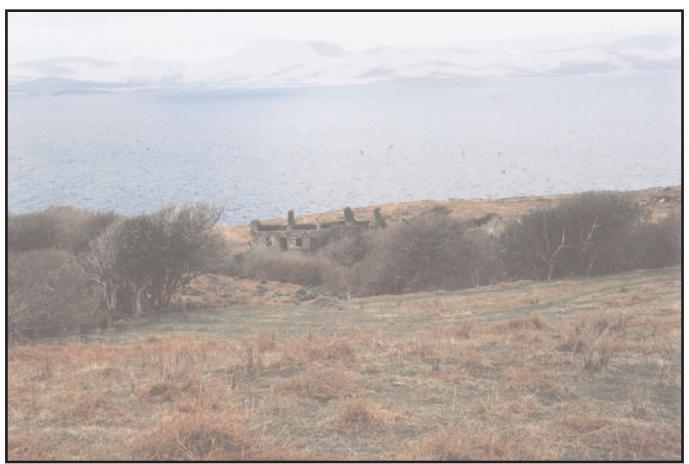
Figures 7-9. Top row. Three views of Glanroon adit. Figures 10-11. Above. The miners cottages at Glanroon. Figure 12. Left. A conjectural drawing of Glanroon wheel pit. Figure 13. Below. The remaining walls of the Glanroon

It is likely that the current adit (Figs. 6-9) just gave access to the stopes as well as being exploratory. The opening section seems to be along a fault as the east wall is completely smooth. It is not possible to get beyond the rubble filled shaft to where the stopes probably lie.

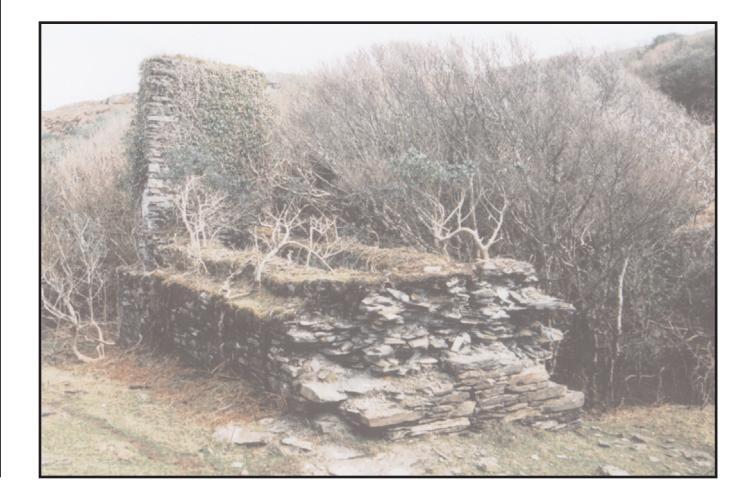
Figure 13. Below. The remaining walls of the Glanroon wheel pit.

Most impressive here are the surface remains with structurally sound miners' houses (Figs.10-11), the remains of a wheel-pit (Figs. 12-13), possibly used for crushing, and a gunpowder house. These structures have probably survived because of the remoteness of the area which also explains the greater wealth of surface material at the even more remote Gortavallig.

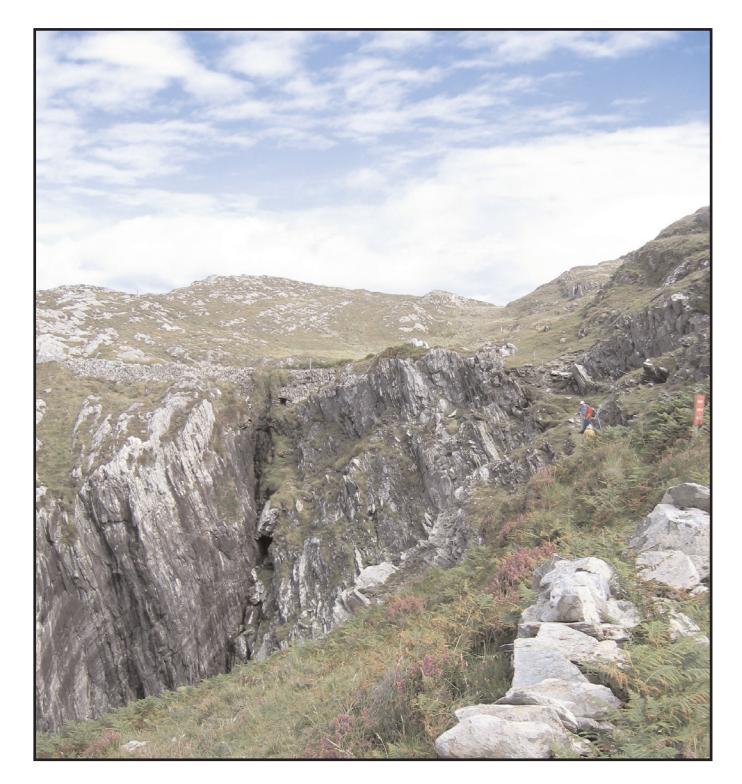
Figure 14. Left. The man made dam holding the cliff top reservoir is seen approaching from the south, past the miners cottages. It provided for water supply on the dressing floor below.

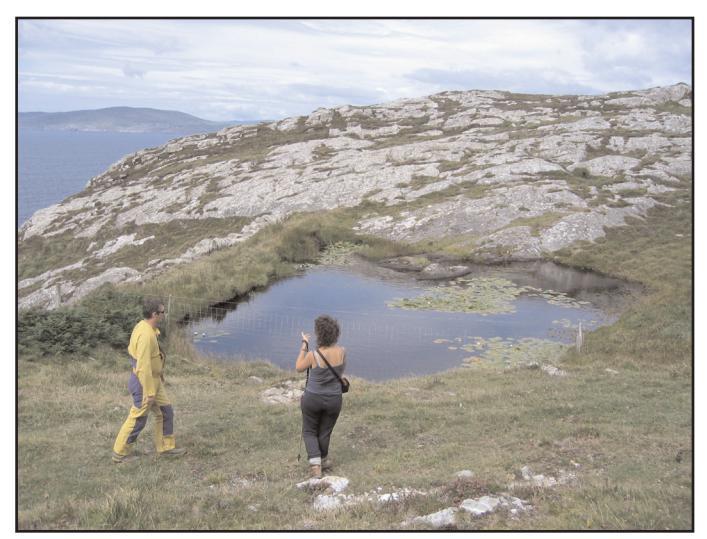
Figure 15. The reservoir on the cliff top.

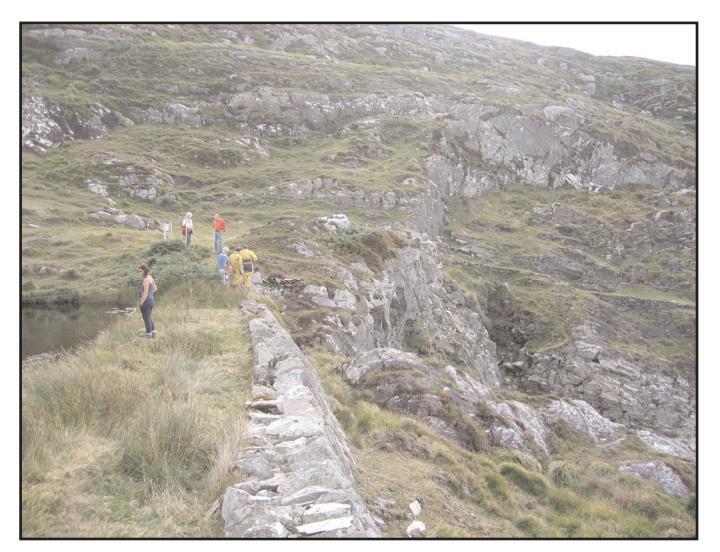
Figure 16. The dam wall of the reservoir.

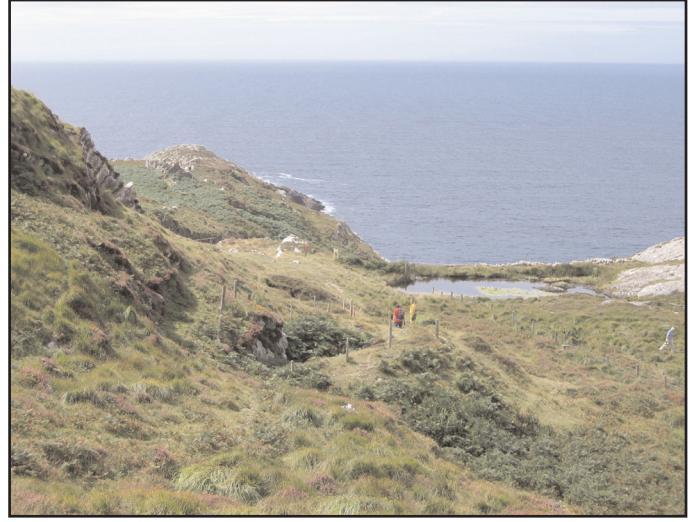
Figure 17. Above. An overview of the cliff top with shaft in foreground, reservoir at cliff edge and miners cottages at far left of view.

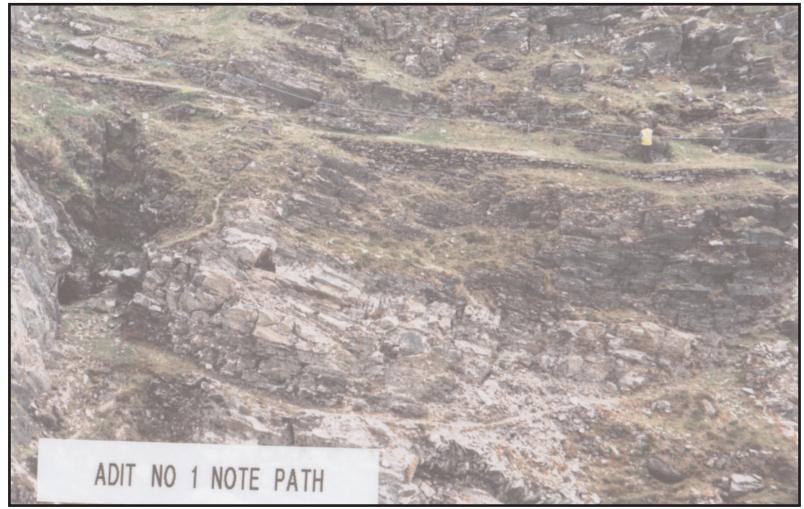
Figure 18. The first adit left of picture. Note cliff path with person in upper part, and lower path between adit 1 and adit 2 in lower half of picture.

Two high-level adits are visible on the cliff-face on the same contour line about twenty metres apart (Fig. 18). One runs east into the peninsula while the other runs west almost parallel to the cliff itself. The first of these is floored with sticky mud punctuated with sheep hoof marks. It has two dry winzes but it is not possible to navigate beyond the second due to lack of footing. During a later visit to the mine Martin Critchley rigged up a transit apparatus and successfully crossed the void to explore the level beyond until brought to a halt by a collapse (Fig. 19) Overhead stopes in this adit are very narrow, barely the width of a man and running up approximately eight metres.

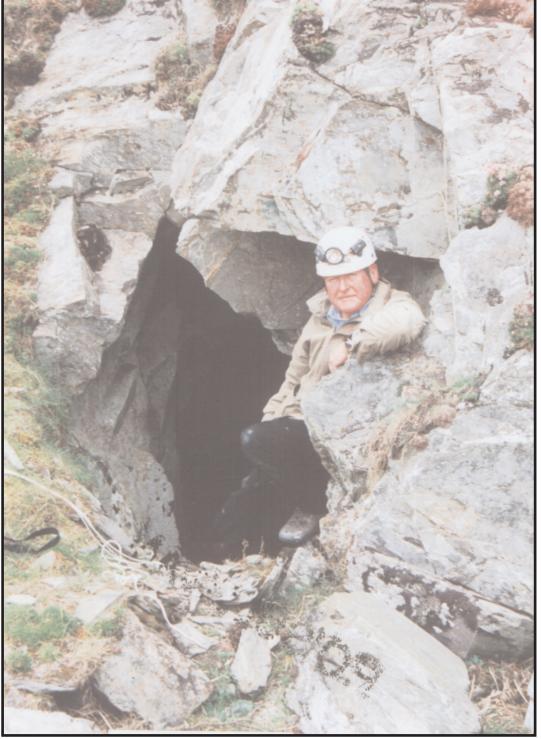
Figure 20. Right. The entrance to adit 2, with author for scale.

The second high-level adit running west is quite different (Fig. 20). Four metres in, a dry winze drops to a then unknown destination. The area ahead is partly filled as a result of a ceiling

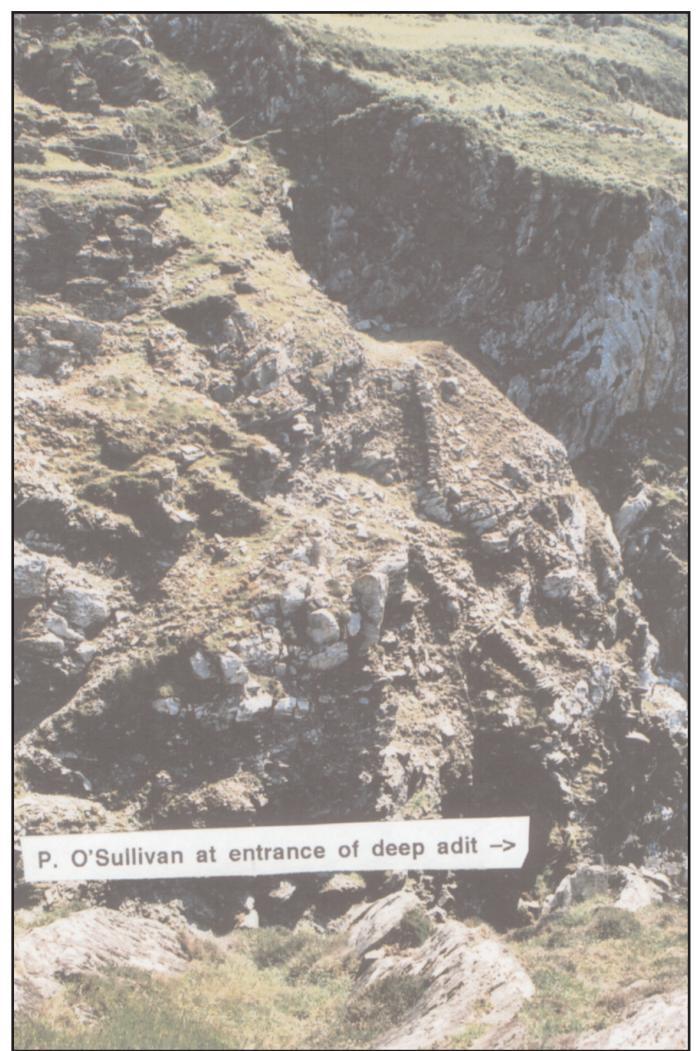
Figure 21. Paddy O'Sullivan at the entrance to the third adit. The distant view from the other side of the inlet shows remnants of paths and possible ore chutes from adit 2 to the dressing floor level below the lower adit.

> A third adit is located about ten metres above sea level. A muchweathered zigzag path weaves its way from top to bottom of cliff, presumably created by the miners. It is still navigable with some care, a safety rope being advisable. This lower adit runs westward into the cliff for about forty-five metres to a T-junction. The left hand branch runs south under the first high adit. Portions of the floor are flooded to a depth of about fourteen inches. From the roof two dry winzes run to the level above as identified by dropping labelled markers from high to low. Broken planking is littered below one winze, presumably the debris of an earlier bridge or catwalk above. From the floor three flooded winzes descend, some with submerged ladders in place. A cave-in obstructed further progress along this branch. Back to the T-junction and heading north along the other branch we came to a large cavern which seems to act as a hub for a series of levels radiating out in all directions. Two flooded winzes run downward from here. In the middle, almost as a work of art, stands a "rock haystack" of carefully stacked waste material. All around are stunning colours on both side-walls and broken rock, greens, azure and turquoise. One of the radiating levels is covered in a few inches of unidentified snow-white liquid. The stulls here typically comprise heavy timberwork angled at forty-five degrees, spanning a one and a half metrewide stope holding up to five metres of waste rock.

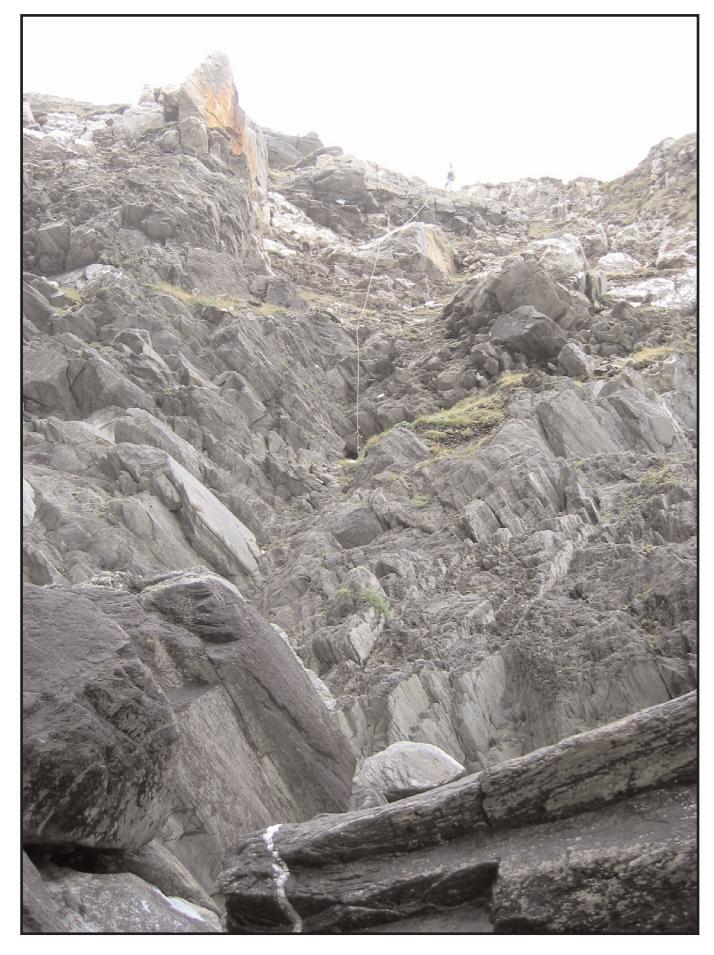
Figure 22. A view up from near sea level to the lower adit in the centre of the picture, at the end of the abseil rope.

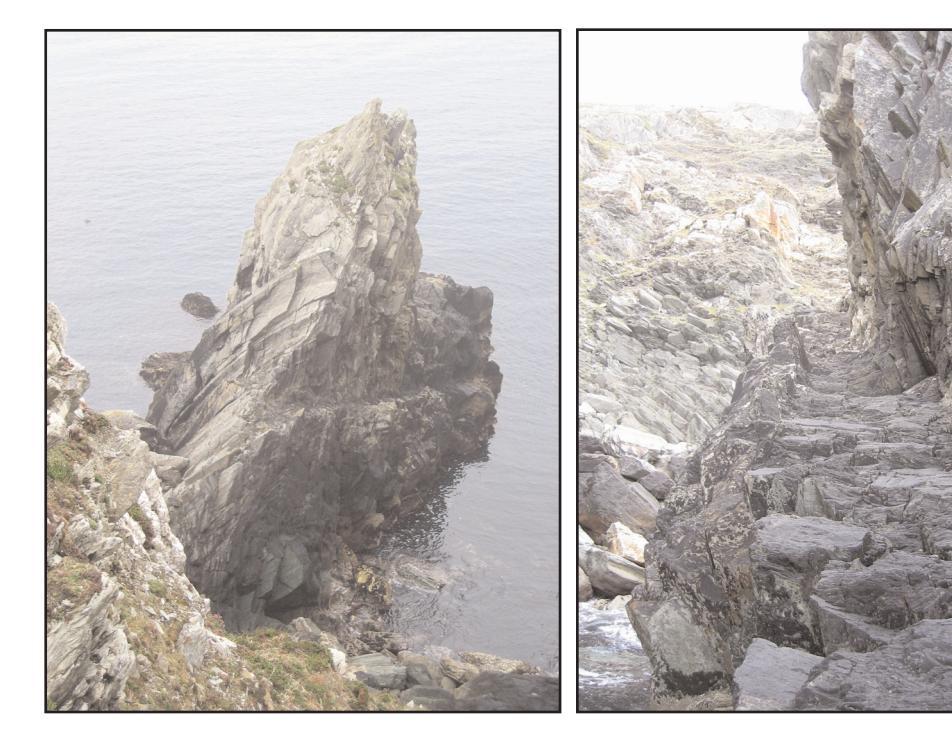
Figure 23. Far Left. A view down onto the quay from dressing floor level, with a clearly cut ramp.

Figure 24. Left. The view up the ramp from near sea level.

fallen rock. A few metres out to sea and surrounded by water on three sides stands a large rock stack. Carved into it is a steeply angled slipway leading right down to the water's edge with powder-blast holes evident. This must have been part of the shipping arrangement ingeniously created by Charles Thomas between 1845 and 1848.

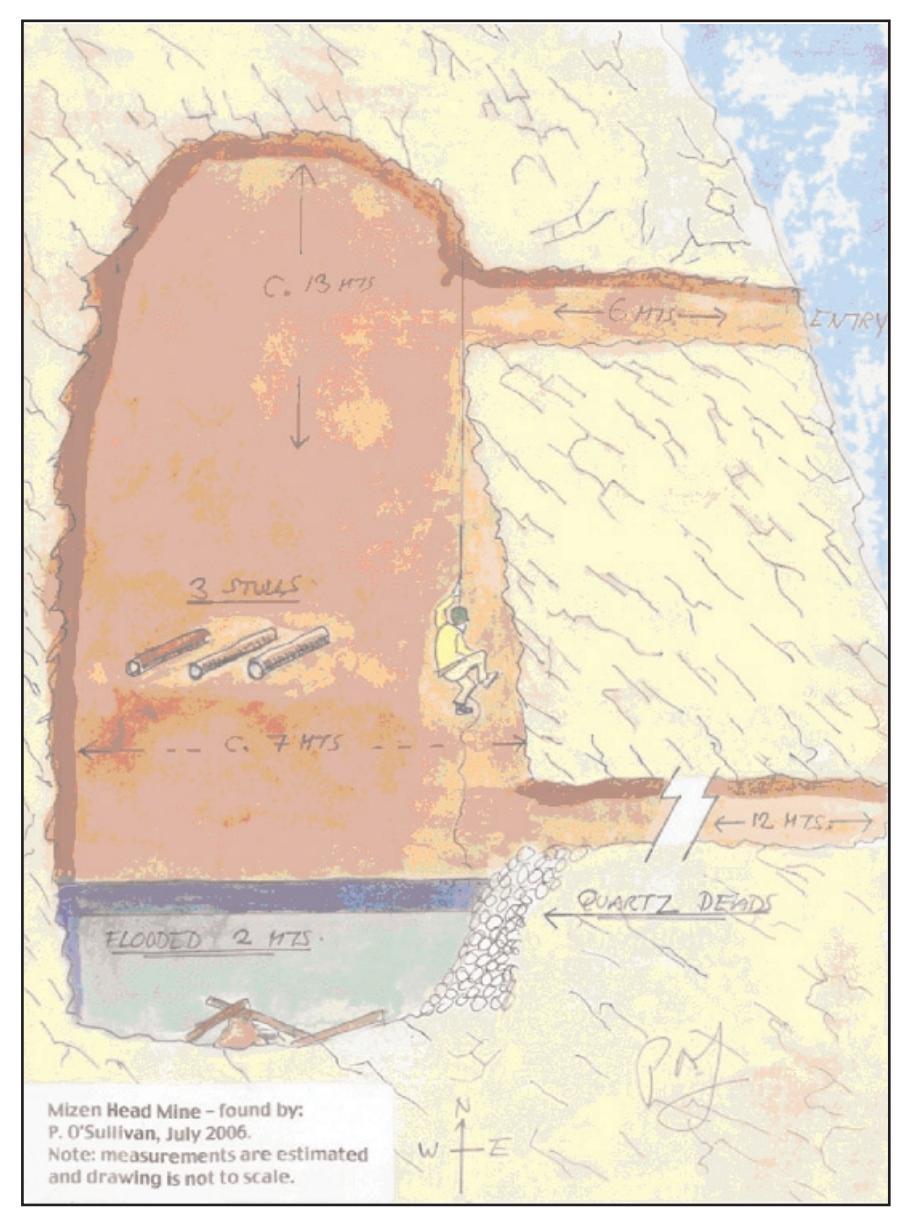
Figure 28. In from the Irish Lights steps the adit leads to this worked-out area which could not be photographed.

my eyes, I inadvertently looked upwards to be greeted by yet another surprise: an opening leading into the cliffs about five metres over my head (Fig. 28). I soon accessed my newfound aperture and noted that it merely ran in six metres to a worked-out stope that had been driven on the quartz vein I had noted earlier from the opposite side.

The level I had just entered led to a stope a mere six metres wide, approximately fourteen metres high and approximately eight metres long. Three timber stulls spanned its width. The entry level was set at almost ceiling height. This necessitated drilling a rock anchor into position and rigging up an abseil rope to access the workings. However, it was not possible to 'bottom out' as the floor was flooded to a depth of two metres. Through the crystal clear water one could see planks littering the bottom which presumably had fallen from the stulls at some stage. From my dangling viewpoint I noted a wall of white quartz stones (deads) shoring up the eastern end of the stope and leading off in a drive twelve metres in an easterly direction to blank end. Unfortunately, It was not possible to operate my camera while emulating Tarzan on a swinging rope. However, a future visit with a short ladder would solve this problem by providing a solid base to stand on.

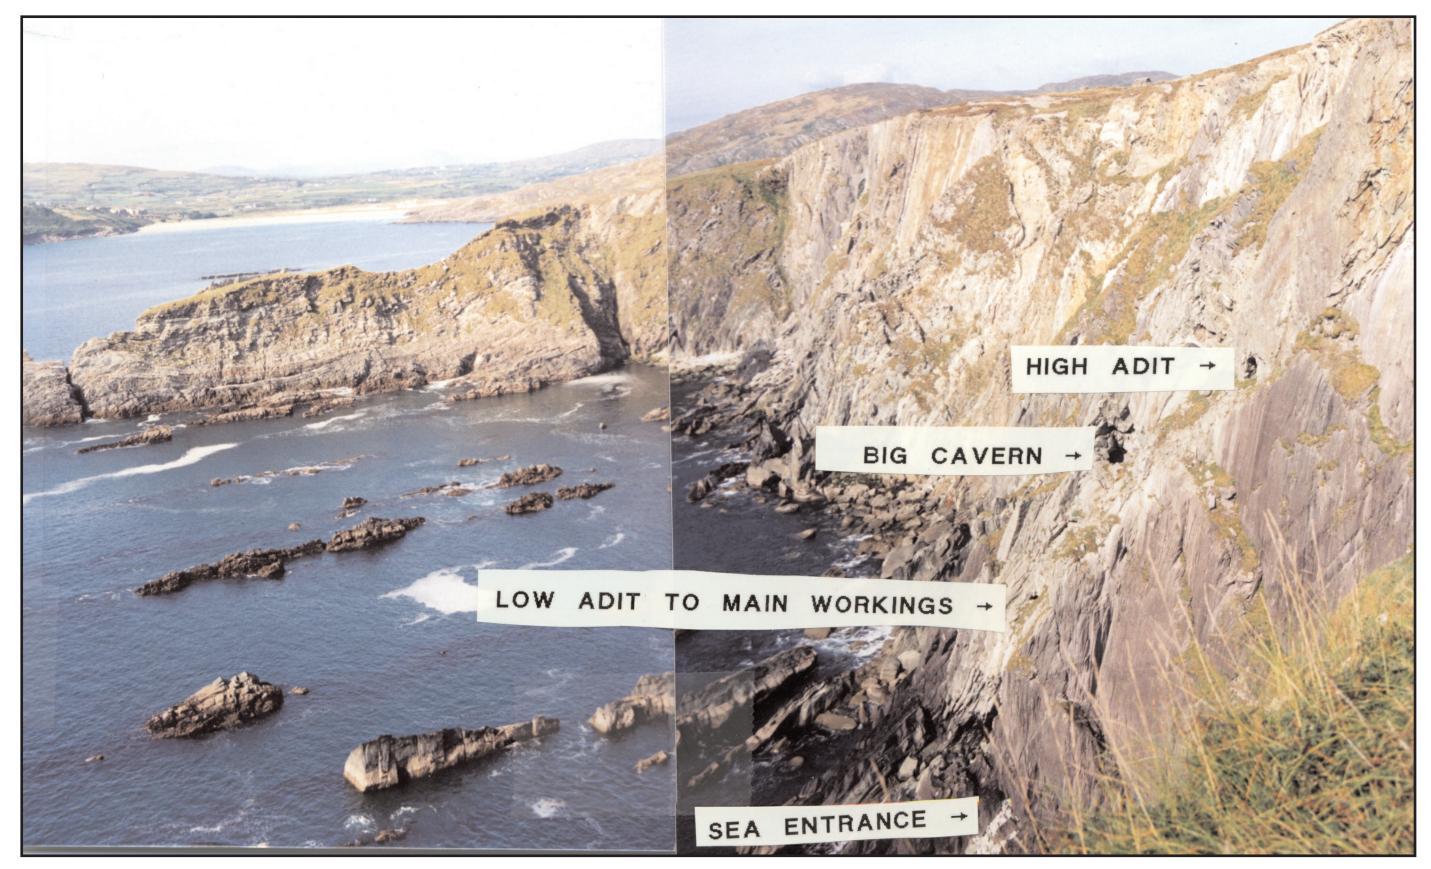
Figure 29. Above. Brow Head "High adit" runs into blank rock at 6 metres with a right hand branch about half way along ending similarly after two metres. "Big cavern" may have been for raising the ore to the cliff-top from the main workings which are 10 metres below. "Low adit" gives access to these 72 metres from the cliff-top. This is linked to the "Sea entrance" adit which is approximately 182 metres long with three minor sinkings and a major one 31 metres below sea level.

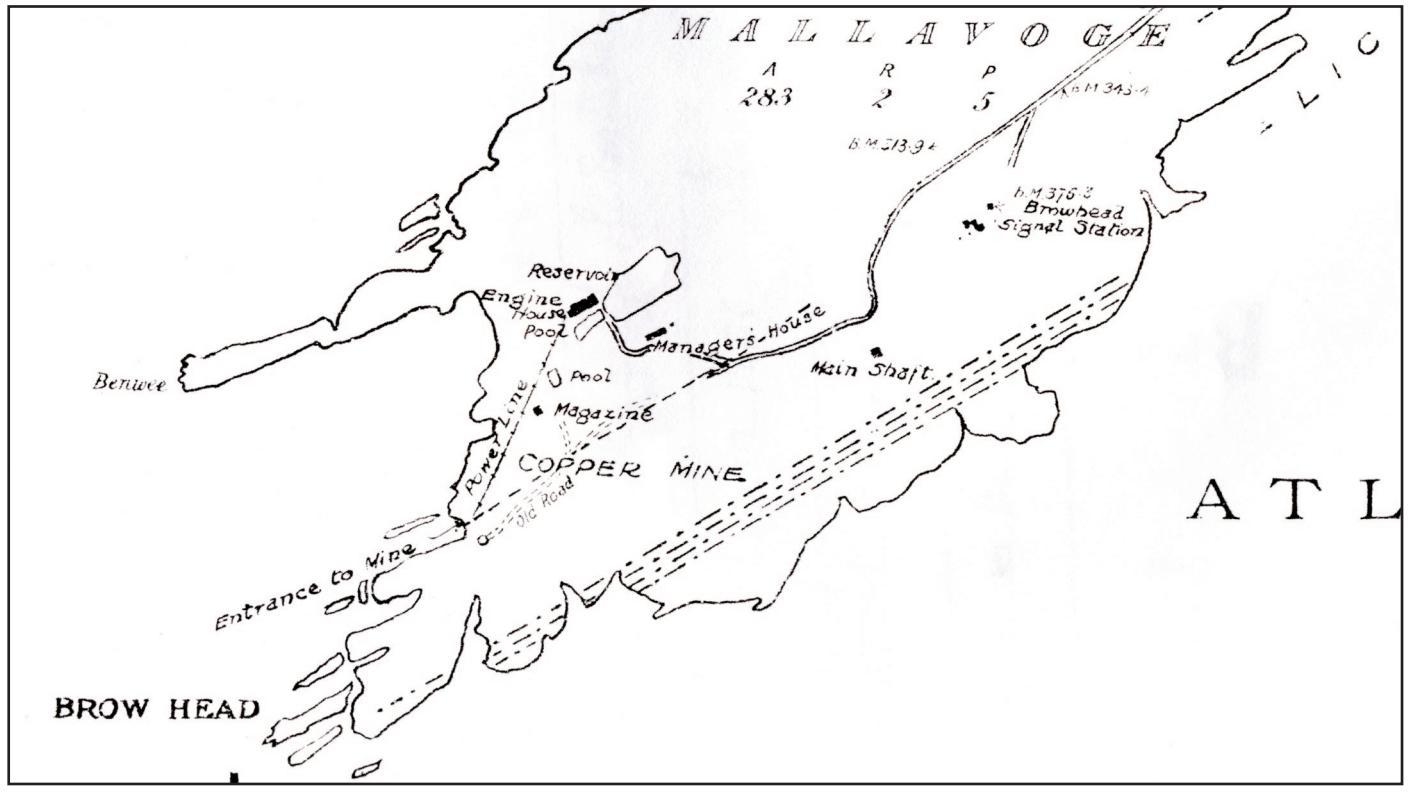
Figure 30. Below. Map of the Brow Head Mine site accompanying a 1906 Prospectus for The Browhead Copper Mines Limited - BT 31/11573/893'3

Obviously a great deal of surface work had taken place and the map (accompanying prospectus) of 1906 shows most of these features plus an engine house beside the reservoir and a "power line" going from it to the mine entrance (a raising mechanism?) (Fig. 30). Remaining evidence of this on the surface are a cobbled floor, mine waste, a large reservoir, a gunpowder house mine houses and cottages (Figs. 31-40).

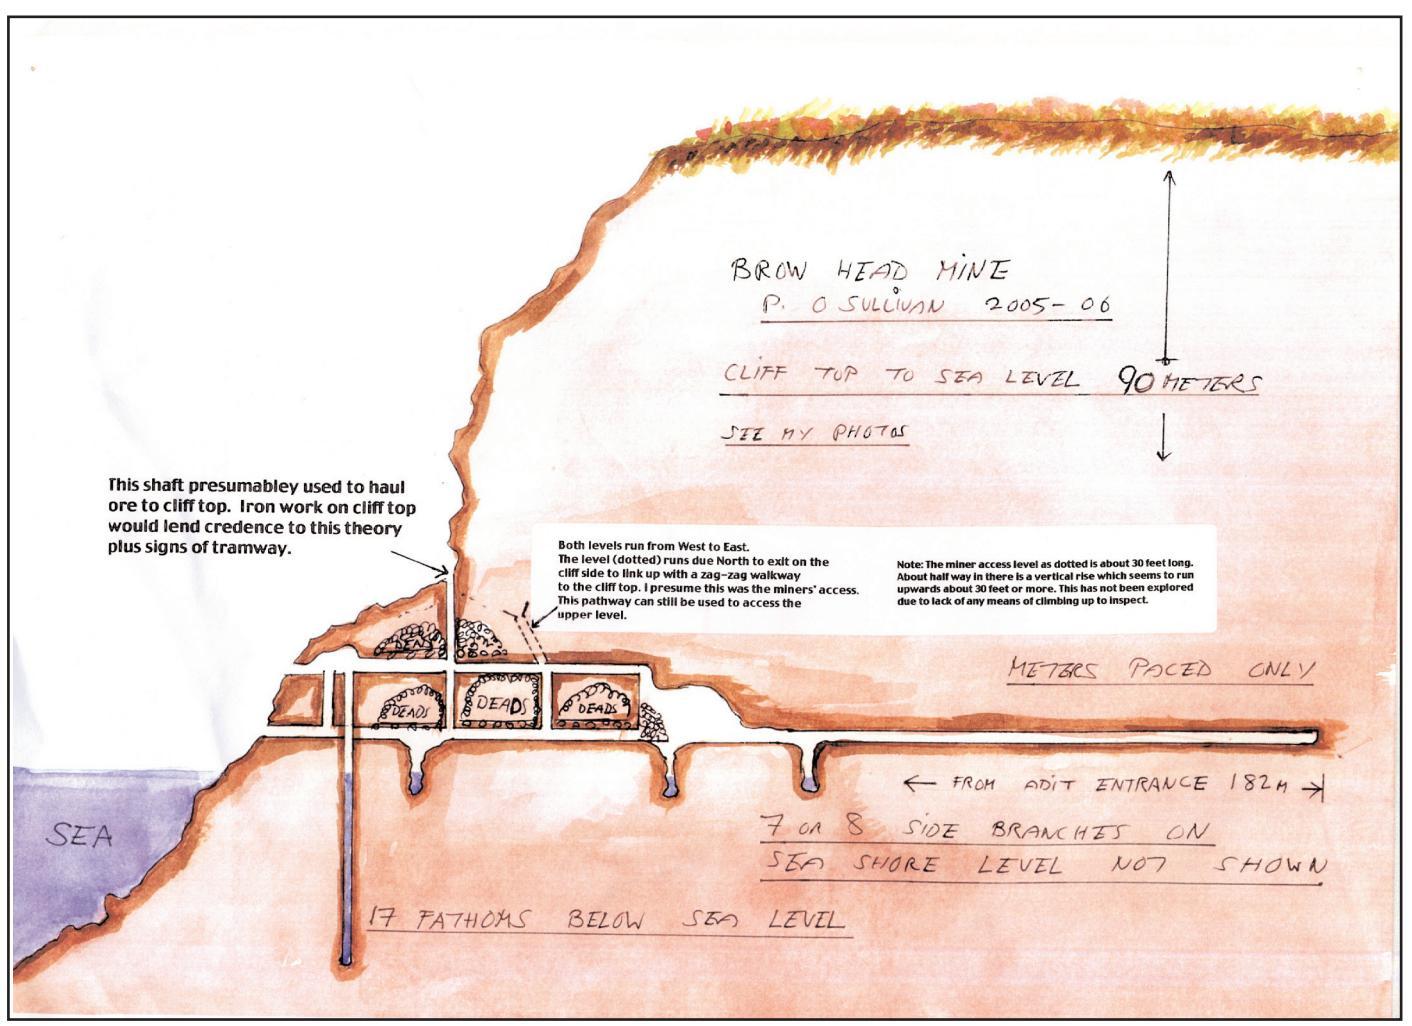
Figure 31. A sketch section of the Brow Head Mine by the author, 2005-6, based on explorations of existing features.

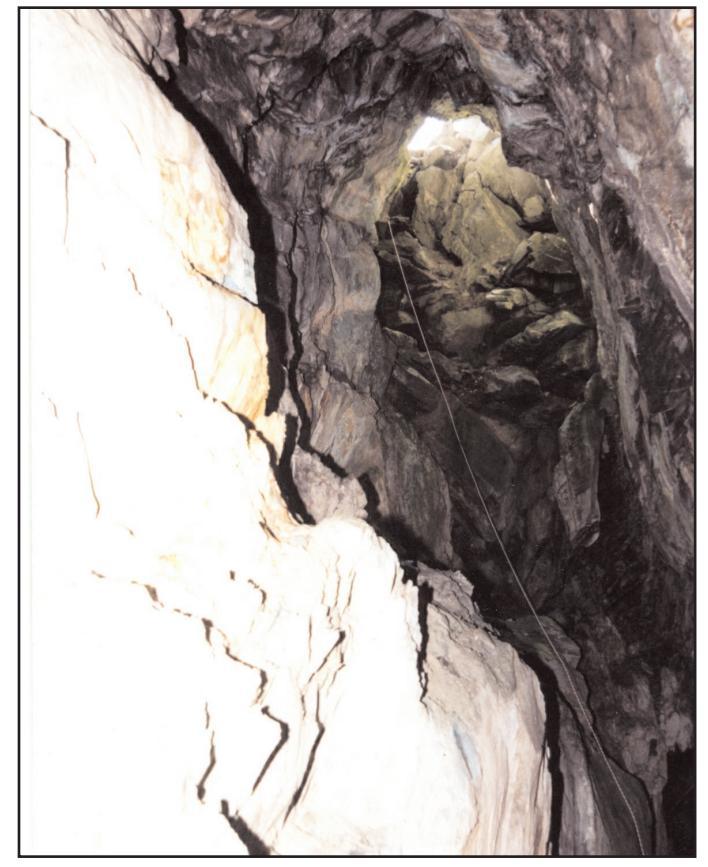
Figure 32. The view from inside the "Big cavern" up to the hole in the roof (of a stoped area?).

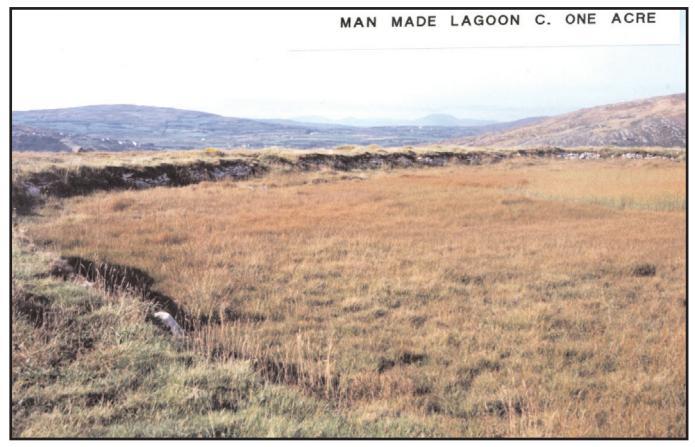
Figure 33. Brow Head Mine - man made lagoon, c. 1 acre.

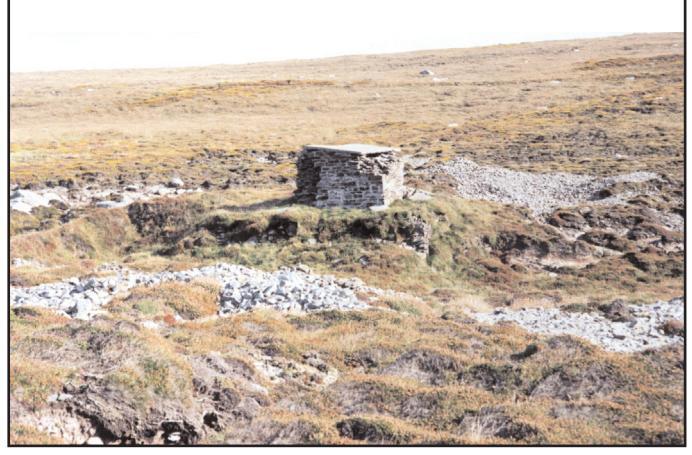
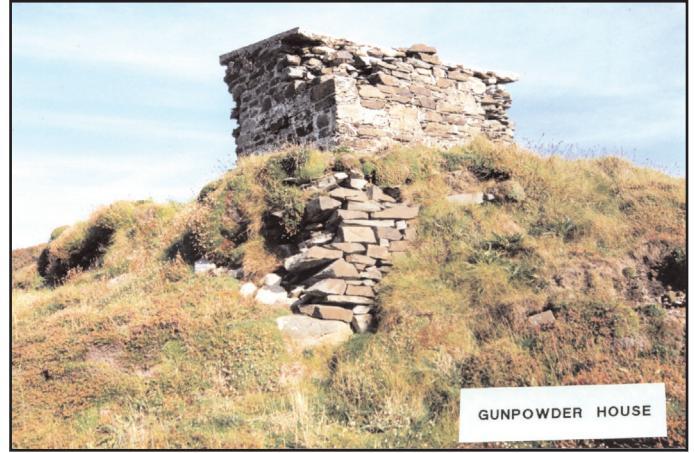
Figure 37. Brow Head Mine - gunpowder house.

Figure 38. Brow Head Mine - gunpowder house.

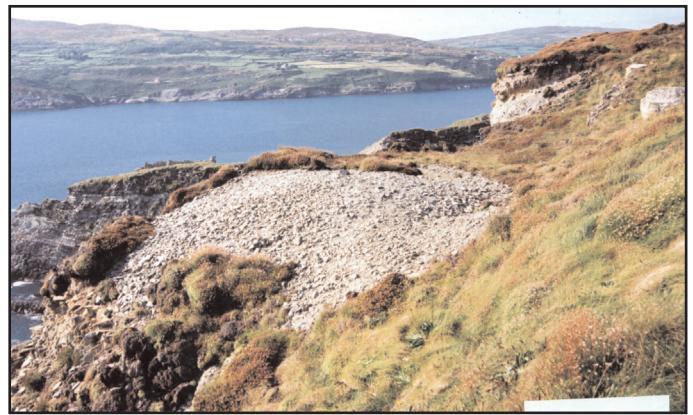
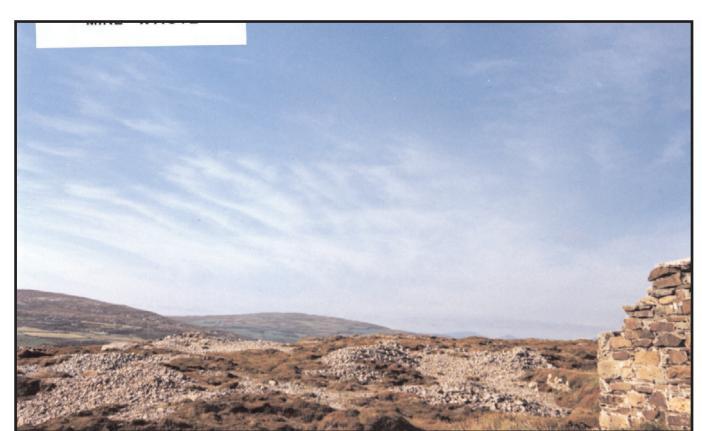
Figure 39. Brow Head Mine - mine waste.

Figure 40. Brow Head Mine - mine waste.

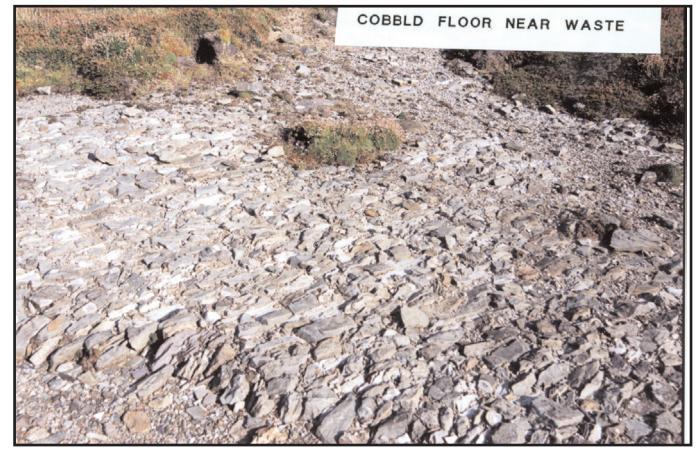
Figure 36. Brow Head Mine - cobbled floor near waste.

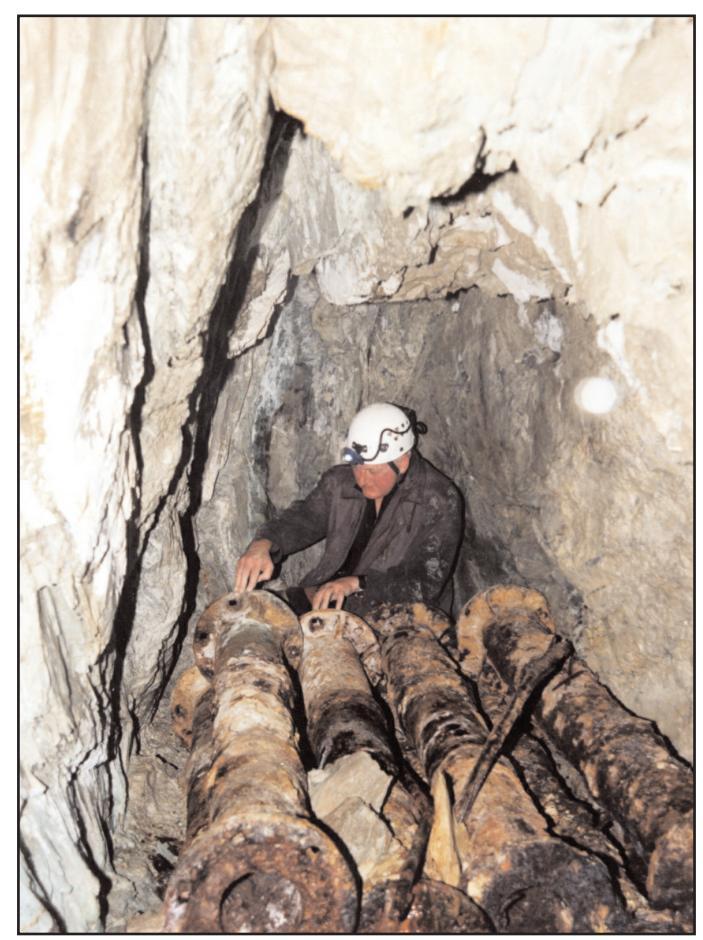
Figure 41. Collections of flanged pipes.

Going by RIB to the obvious opening, above high tide level revealed an adit with an immediate deep shaft and some lesser ones. Overhead were stulls, probably arising from 19th and 20th century phases of working. Then there was a collection of flanged pipes lying horizontally that looked as though they had once pumped the 70f shaft below sea-level. One, however, was later (c. 1906?) used as a roof prop. There were also bits of ironwork and stored ladders that were probably from the later work-

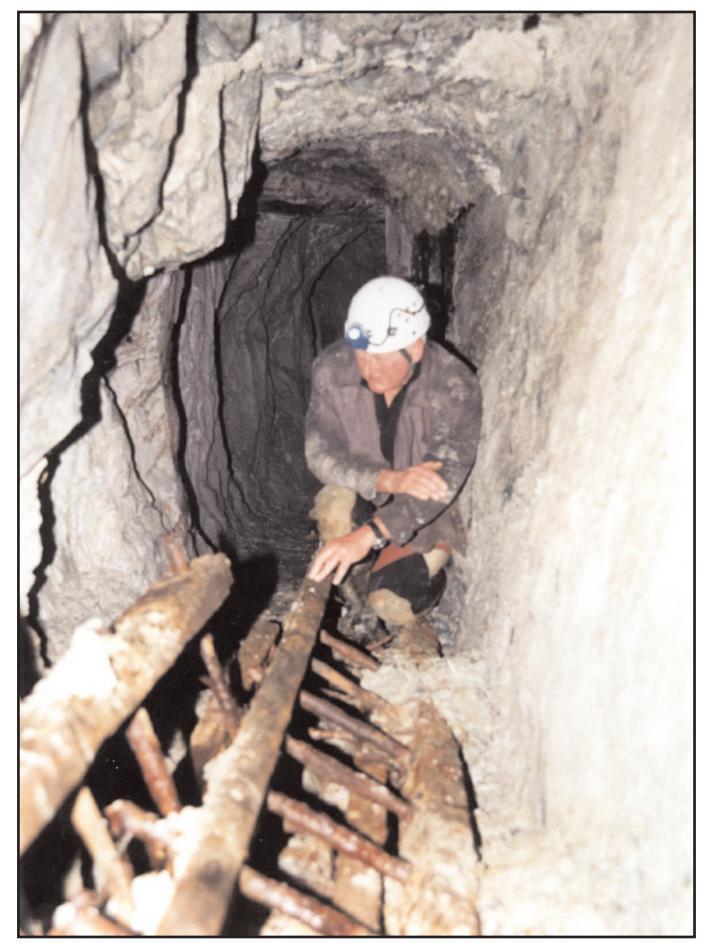
Figure 43. Ladders stored in the adit, with the author.

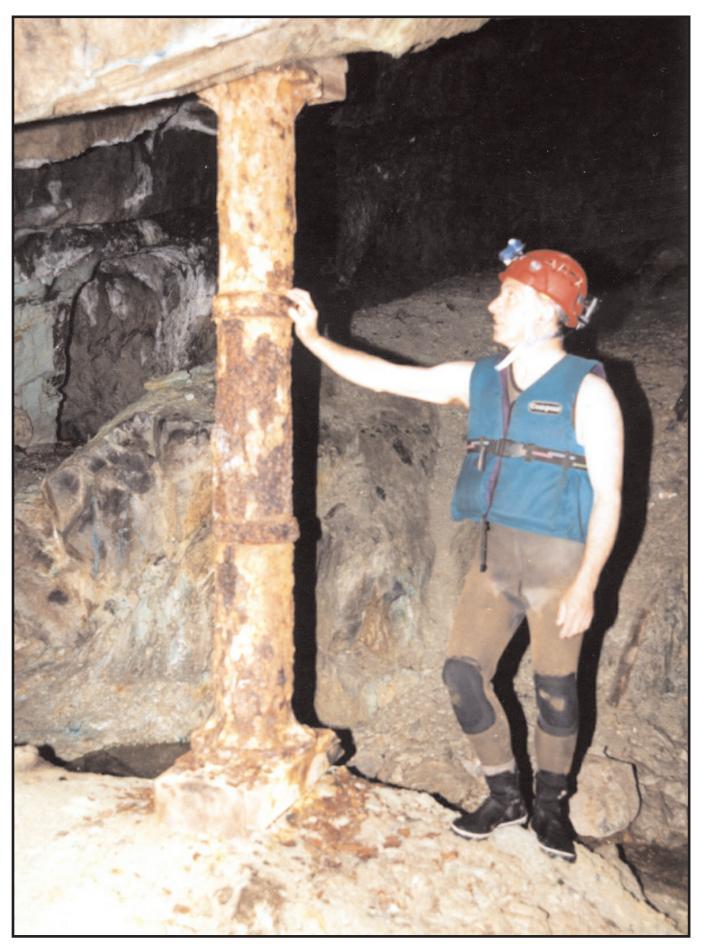
Figure 42. A flanged pipe used as a roof prop.

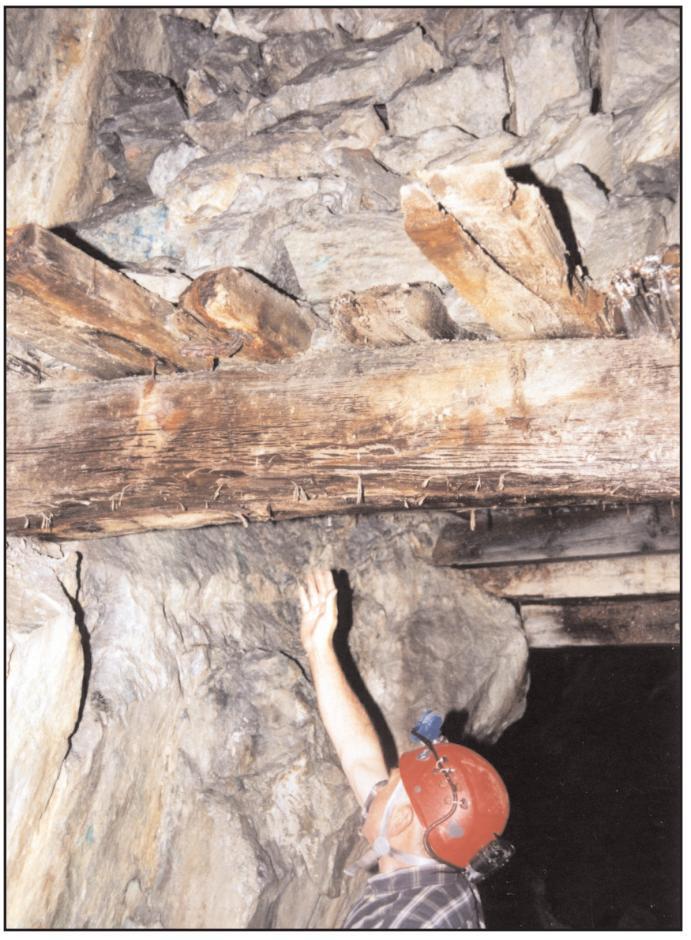
Figure 44. Stulls with stacked deads.

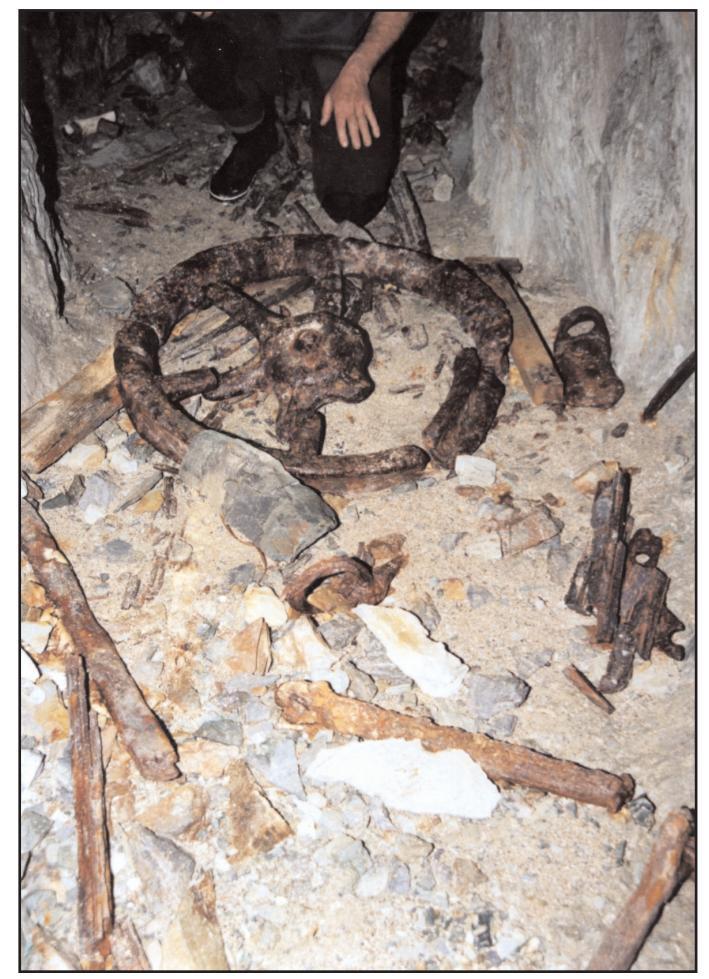
Figure 45. Remnants of a windlass?

ing as per adjoining underground illustrations (Figs. 41-45. A strong wooden base very well secured to the mine floor must once have been mounted by a hand-windless.
